November 2, 2017

The Nautley River Hydrologic Control

NADLEH WEIR SURVEY 2017

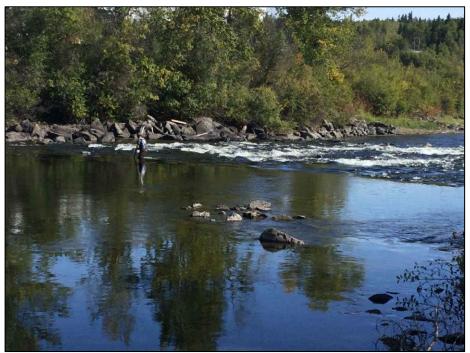
Plate 1. Nautley Hydrologic control, October 2017

The surveys were used to characterize hydrologic control stability and to determine whether the hydrologic control continues to provide a stable hydrologic control on the outlet of Fraser Lake. Tom confirmed that he was able to located and re-survey many of the same points that were surveyed in 1993, and thus found little change in the overall cross-section geometry. He has concluded that the control structure has not noticeably changed since 1993. Surveys were completed with the same makes and models of instrumentation (just different generations), and thus not only was a comparison of surveys possible, but exact survey locations were able to be located at many of the 1993 survey points.

Available evidence supports the conclusion that the Nautley Hydrologic control has remained stable and is not structurally different from its original 1993 survey. It is my professional opinion that changes in Fraser Lake levels may be driven by variability in natural flows out of Fraser Lake, observed in the WSC record, and that there is a general decline in mean annual discharge, and differences in the distribution of mean monthly discharge. Should you have any questions or concerns, please do not hesitate to contact the undersigned.

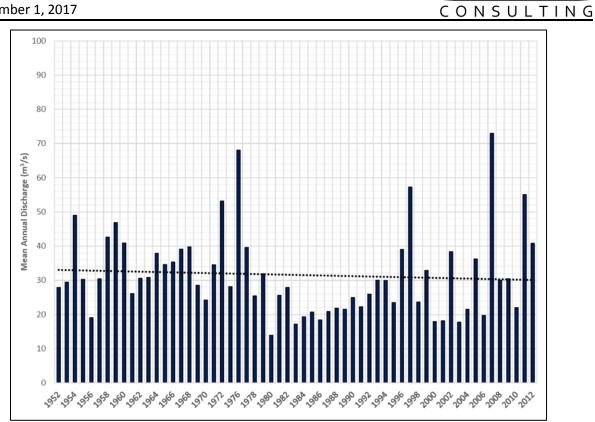
Figure 2. Mean Annual Discharge from Nautley River Near Fort Fraser. The dashed line forms the trend of annual discharge

Perhaps related to comments regarding lake levels, it is important to consider that mean annual discharge from Fraser Lake, though variable throughout the record, is tending to decline, as shown on Figure 2, suggesting that lake levels will be generally lower, on an annual basis. The monthly distribution of runoff is also variable, as shown on Figure 3. On average, all months except April and May show a general decline in discharge since the start of data collection. Freshet tends to commence in April, with the highest flows occurring in both May and June. The net result of these trends is that, when compared with the original installation streamflow characteristics, Fraser Lake tends to have higher levels in the early Freshet months and lower levels in all other months. These changes are unrelated to stability of

the Nautley Hydrologic control, as it is assumed that the WSC rating curve would consider any alterations. Hence, it is possible that changes to lake levels may be the result of a natural decline in discharge from Fraser Lake.

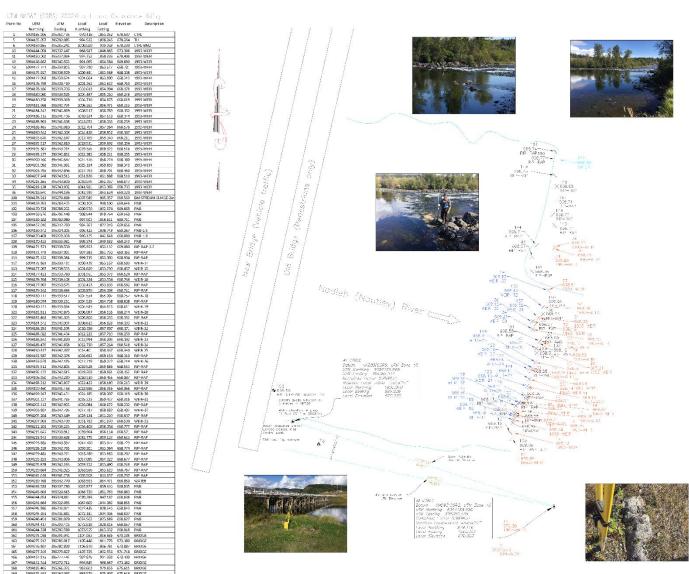
ANNEX C: T&T Surveys Ltd. 2017 Nautley Hydrologic control Survey

A stakeout file was computed from the original 1993 survey plan coordinate listing provided by Bill McIntosh, and uploaded into the data collector. Individual points from the 1993 survey were staked out and recorded are shown on the present site plan. For the most part the elevations agree with the 1993 survey to +/- 0.03m. At the beginning of our 2017 survey, navigating the slippery rocks was difficult until we got the system down and we missed the exact locations of original points 14-17 showing slight differences in elevation.

It is my opinion that the weir has not moved since the W.D. McIntosh survey of 1993.
