Recruitment failure – identifying and reversing the causes

Nechako River: retrospective analysis of recruitment failure (Trans. Am. Fish. Soc. 134: 1448-1456)
(Diagnosis)

Nechako: medium and large scale restoration (field experiments)

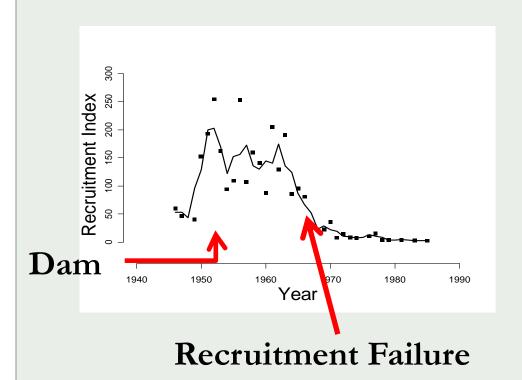
Increased Riverbed Elevation

• Recruitment failure coincided with substrate alteration, i.e. a shift to aggradation

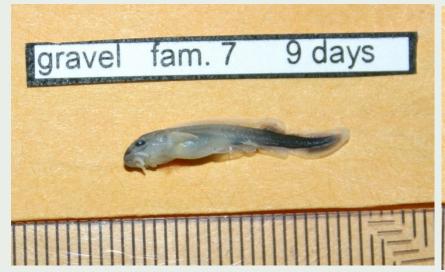
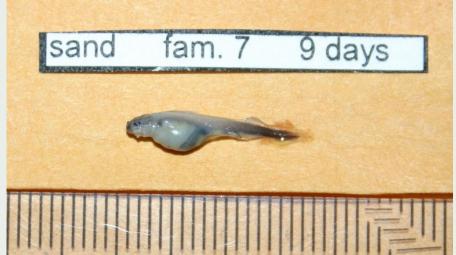
Physiological effects of substrate rearing (lab studies)

Boucher et al. (2014)

Gravel rearing of yolksac larvae affects:

- growth and morphometry
- gut development
- survival
- swimming ability
- metabolism
- stress hormones

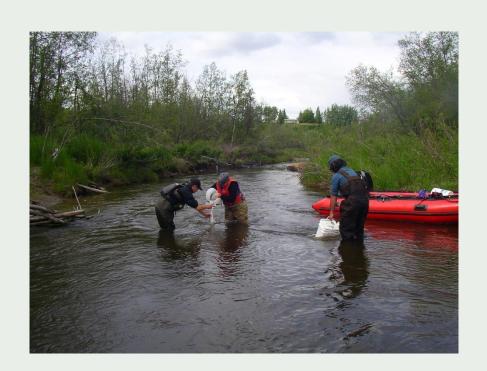
Medium scale habitat restoration (Restoration: 2008)

- Increased scale of restoration experiments
- In-river investigation of medium scale restoration
- Gravel placed in side channels (thanks Wayne)
- 1 day old larvae released
- Monitoring to detect larval retention and drift
- Provided 'proof-of-concept'

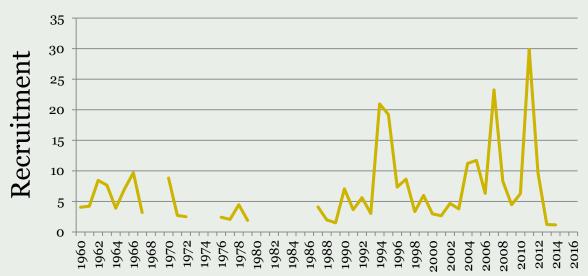
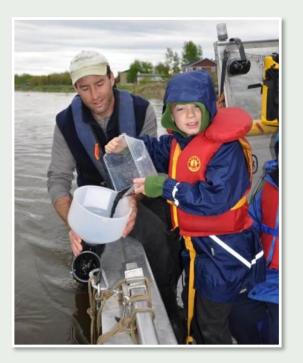
Biological responses

- Spawning over pads confirmed in 2012,
 2014, 2016 (egg mat sampling)
- Increased capture of wild juveniles
- Age of wild juveniles supports link to 2007 (high flow) and 2011 (restoration)
- Genetic parentage evaluation indicates success

300,000 Eggs Placed in 2011

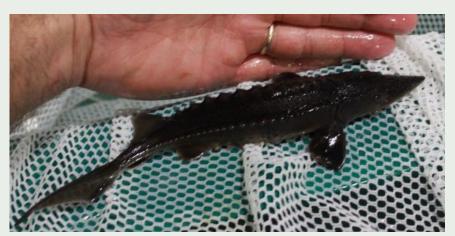
2014 – Nechako conservation hatchery

- Sited within a known spawning reach
- River water intakes (temperature and imprinting benefits)
- Substrate rearing of yolksac larvae

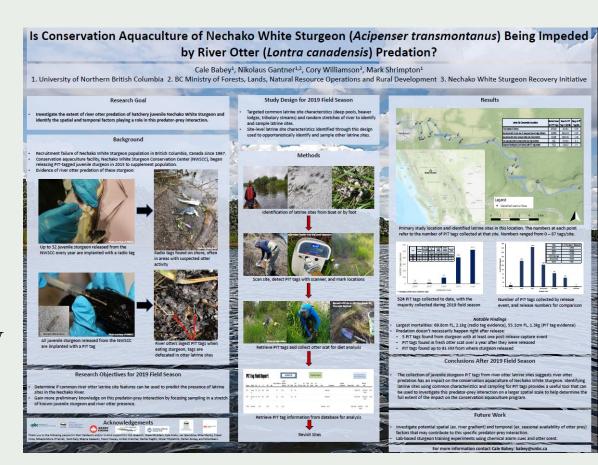
River Otter predation study

- Predation by otters and others (raptors) and emerging concern
- >520 PIT tags recovered in latrine & feeding sites
- Radio tag recovery confirms mortality (perhaps 50%)
- Largest fish consumed by otter >70cm
- Shifted to releasing fewer larger fish
