WEI – Operations & Reflection 2021 Illustration

Prepared by Andrew Czornohalan
and Alec Mercier
27 September 2021

2021 Reservoir Operations

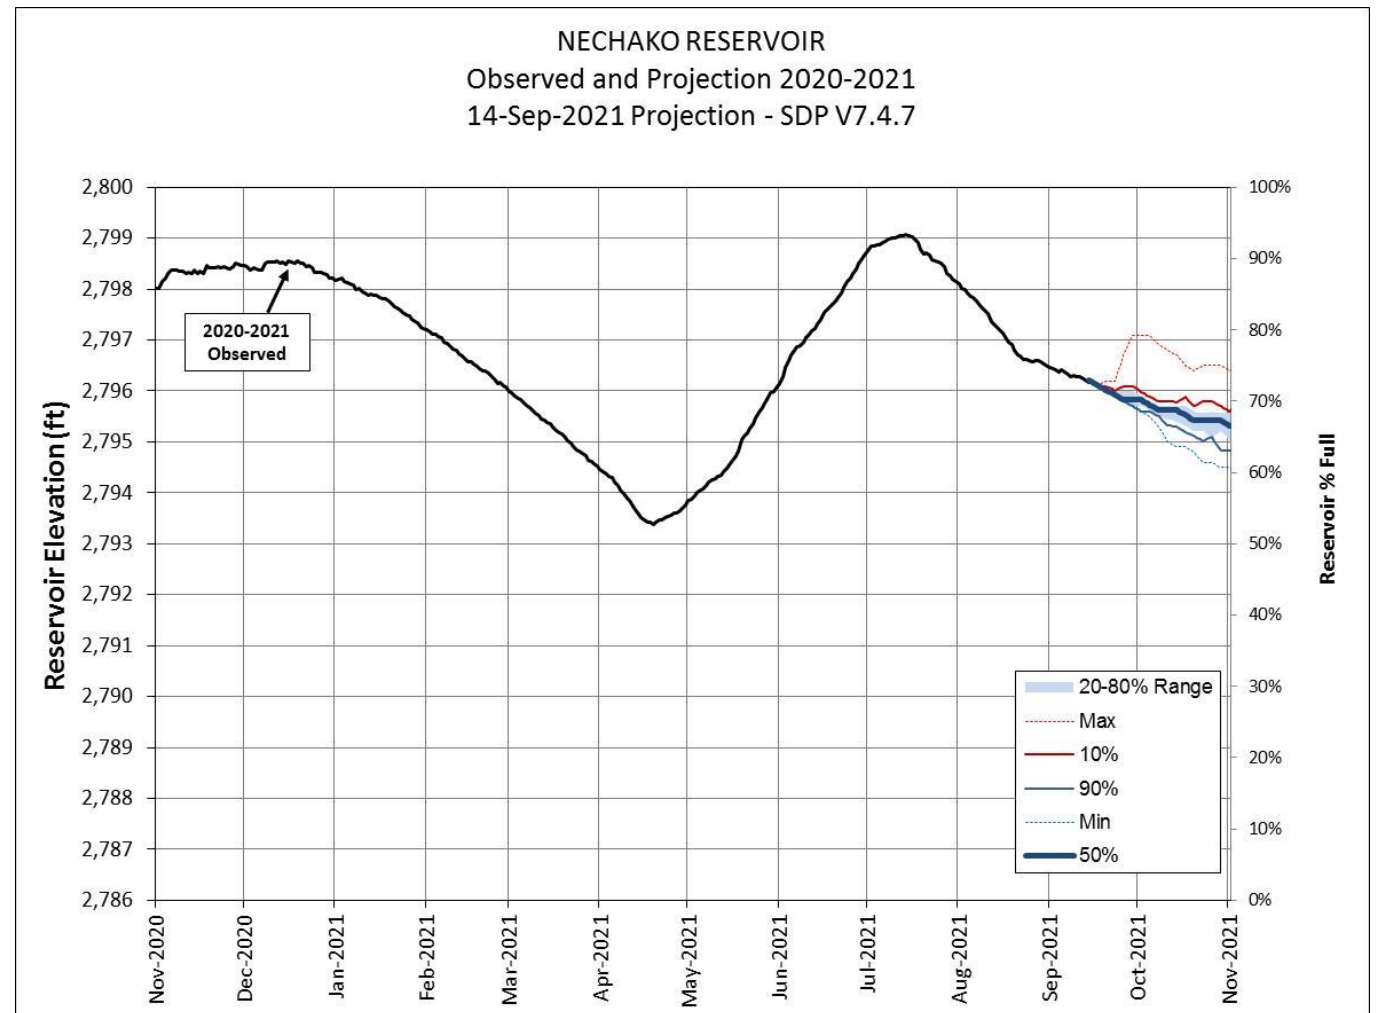
Reservoir Level Projection

- Inflow projections are used to estimate reservoir levels over time considering current hydrology and historically observed additional snow and rain.

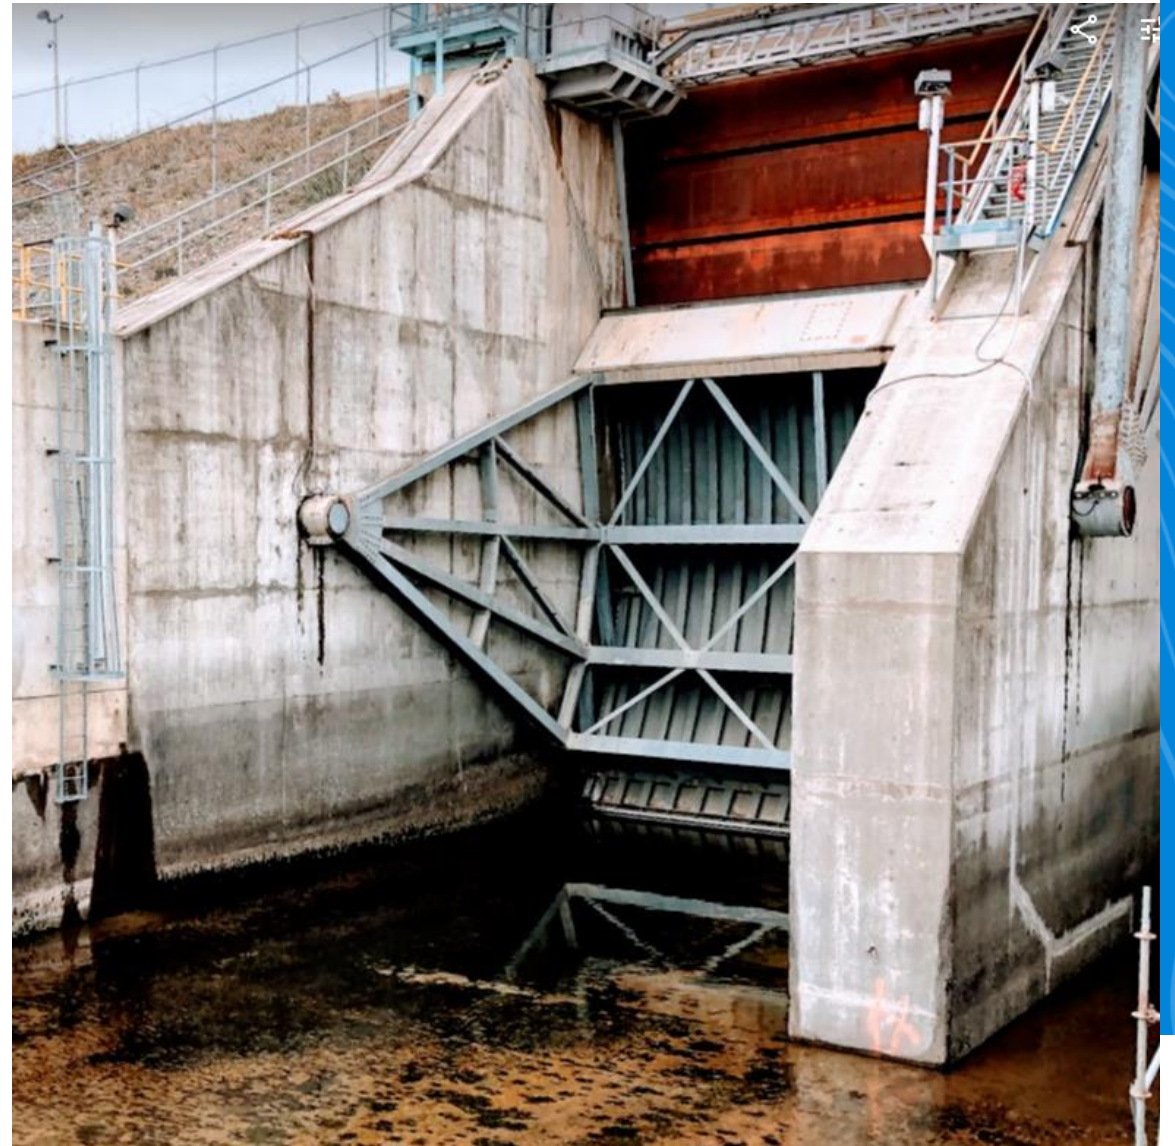
Consideration for September Spill (Re-cap)

- Reduced Smelter Production given labour dispute
- NFCP technical committee provided guidance with 2 criteria
 - September > min spawning flow (31.1cms) up to max (125cms) for Chinook spawning
 - At end of September need to consider maintaining a minimum of 50% flows as determined in September through winter for incubation
- The current Rio Tinto reservoir management model suggests spilling on average 120 cms for the month of October.
- Historically spill would be 14.2 cms at the end of the STMP period in August and then 32 cms for the month of September and throughout the winter aligned with the NFCP requirements.
- Critical Dam Safety Spillway maintenance – See following
- Feedback and interests from First Nations and Community Engagement (WEI) factored into the decision making

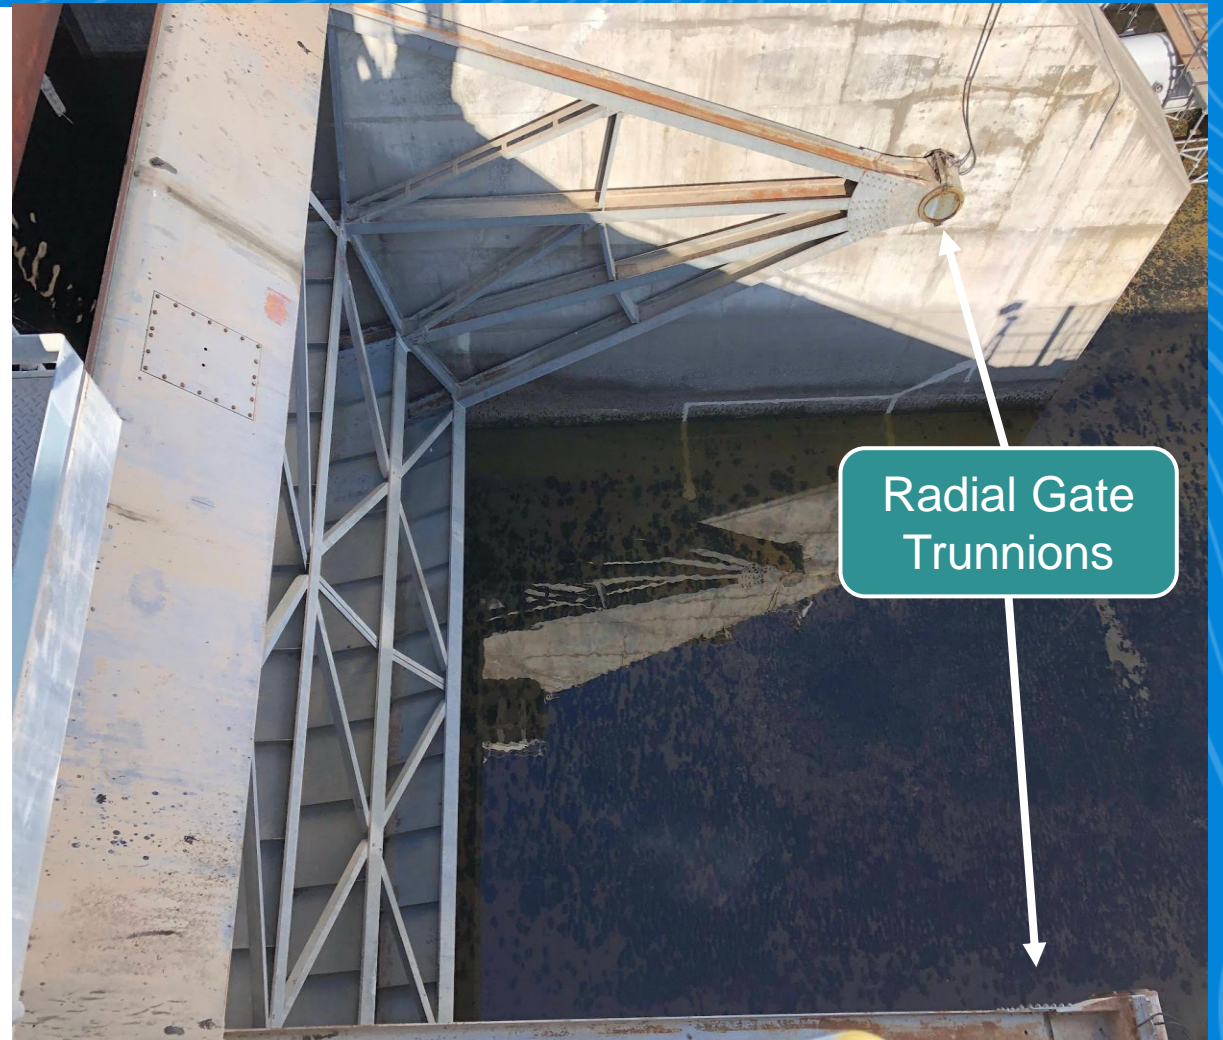
Upcoming Radial Gate Inspection

- The inspection is scheduled for week of September 27th and typically would require low flow through the gates.
- Worked on 3 Options to lessen or eliminate the impact:
 1. **Maintain 80cms through one gate, and switch sides as needed – confirm with contactor any increased risk and controls required**
 2. Day & Night approach – 40cms 12hours throughout the day then 120 12 hours overnight seeing the same average across a 24 hour period. To be reviewed with Cheslatta and Eco Fish
 3. Pre-Load approach – increase spill for days / week prior to works and keep spill low throughout. Least preferable given downstream interests
- Option 1 is confirmed and work will start as planned on the 28th

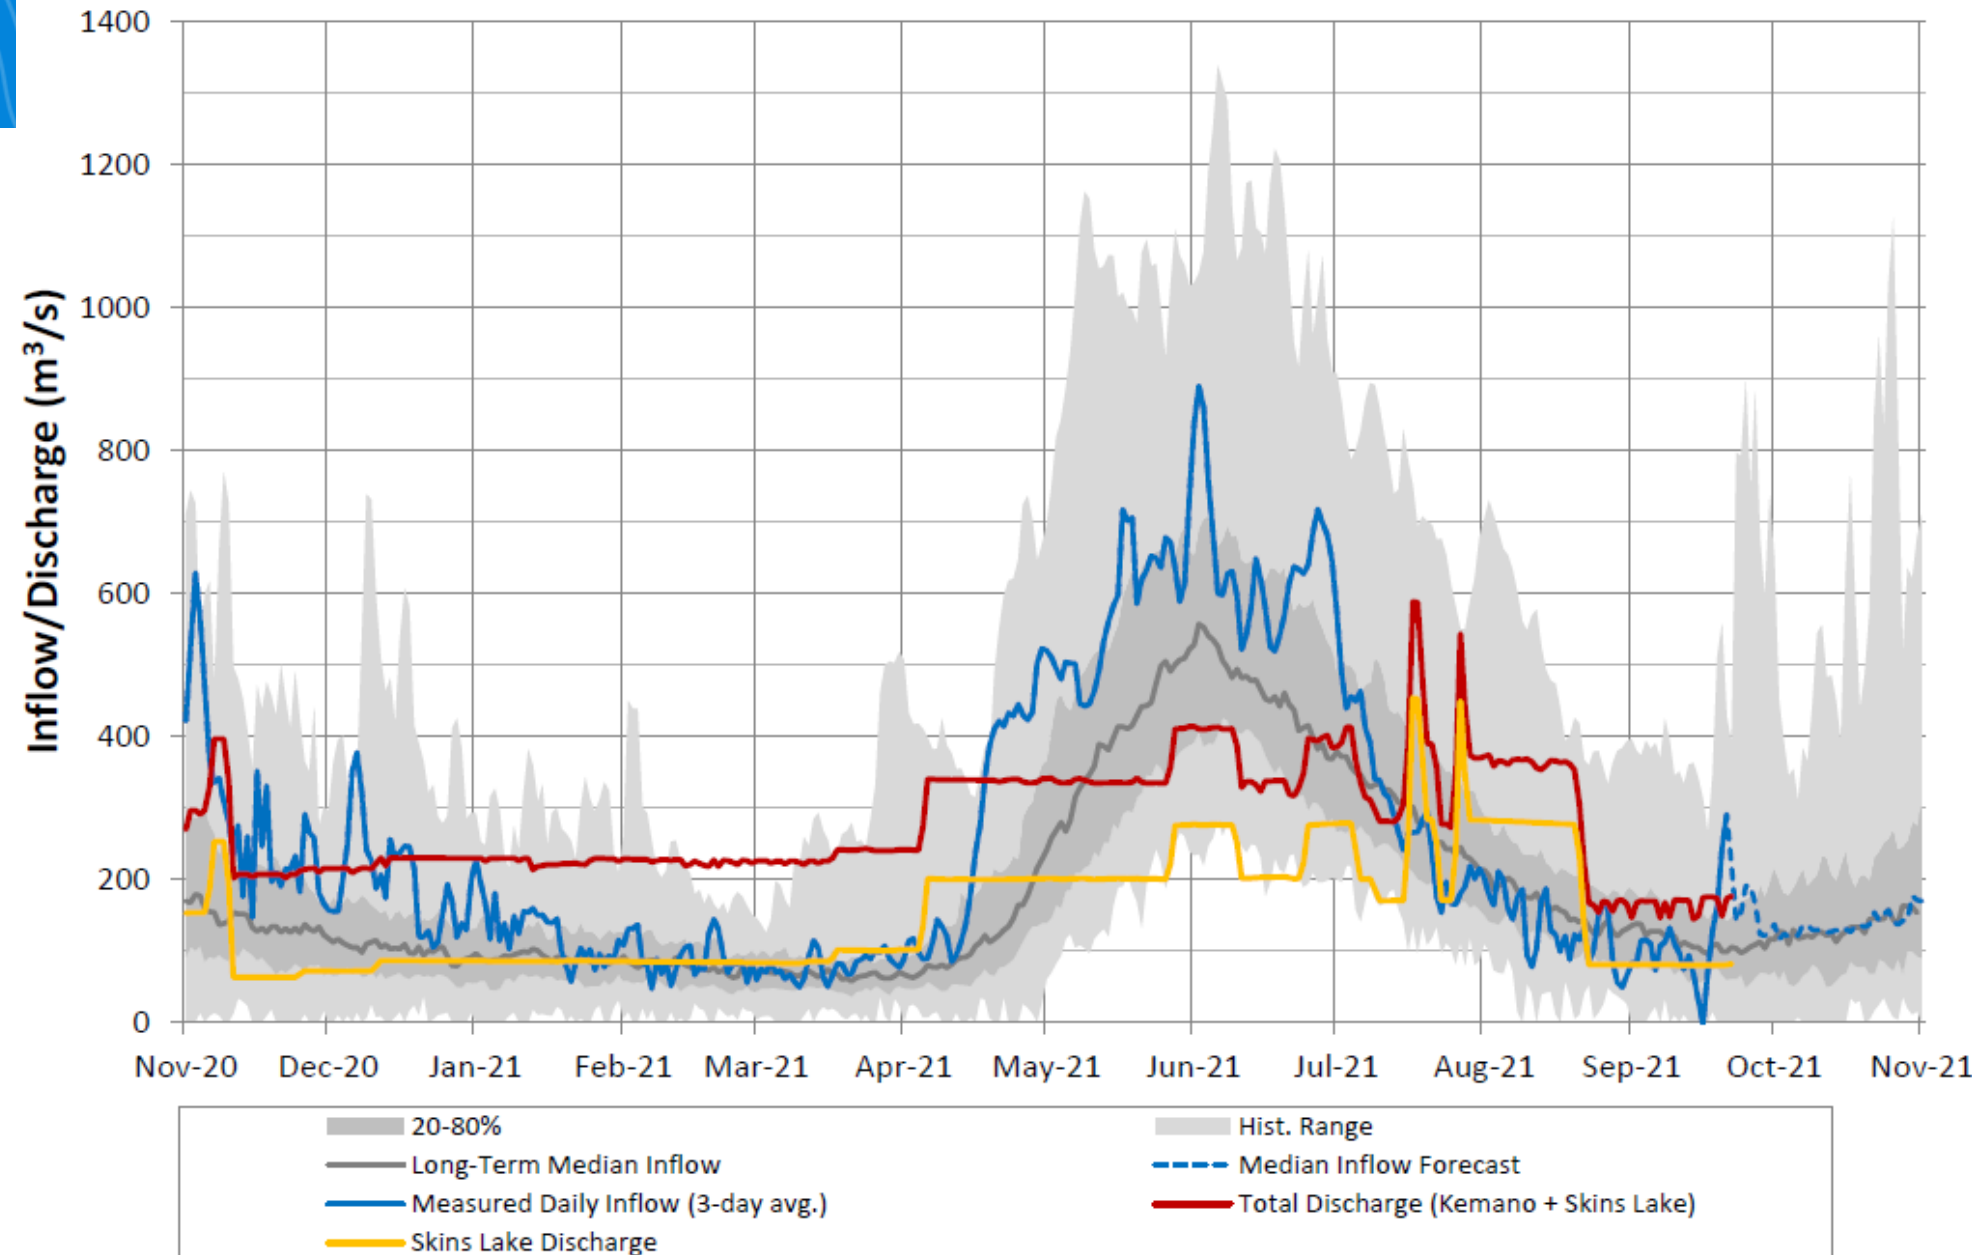
Full Year On a Page

Nechako Reservoir Operation Observed Inflow and Discharge 2020-2021

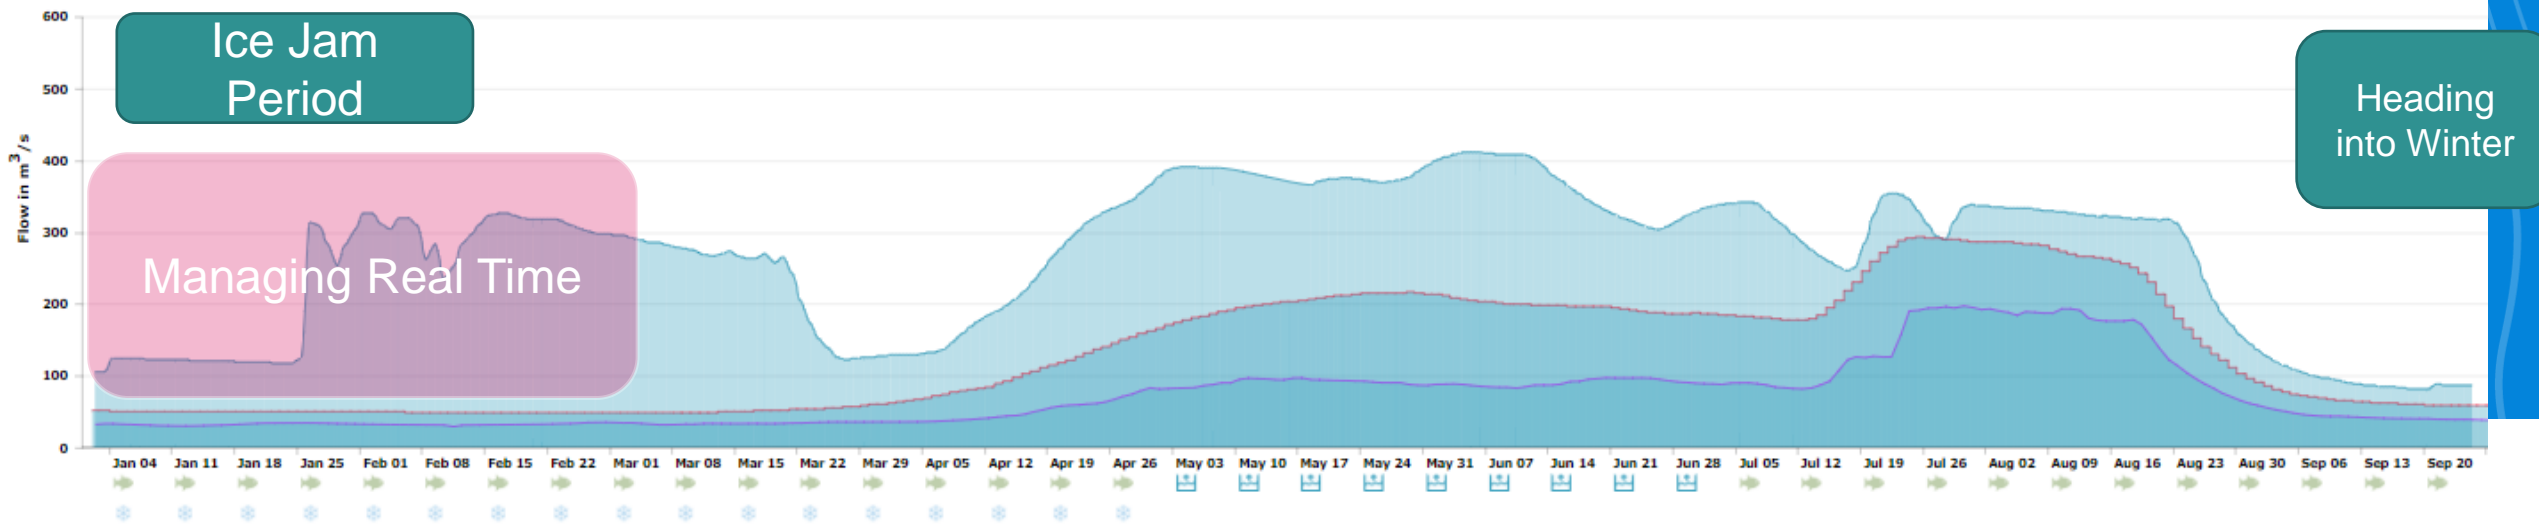
Note on Nechako River at Vanderhoof Metrics - Nechako River flow data is not accurate during winter months due to ice cover. Please do not rely on the data shown below from October to April.

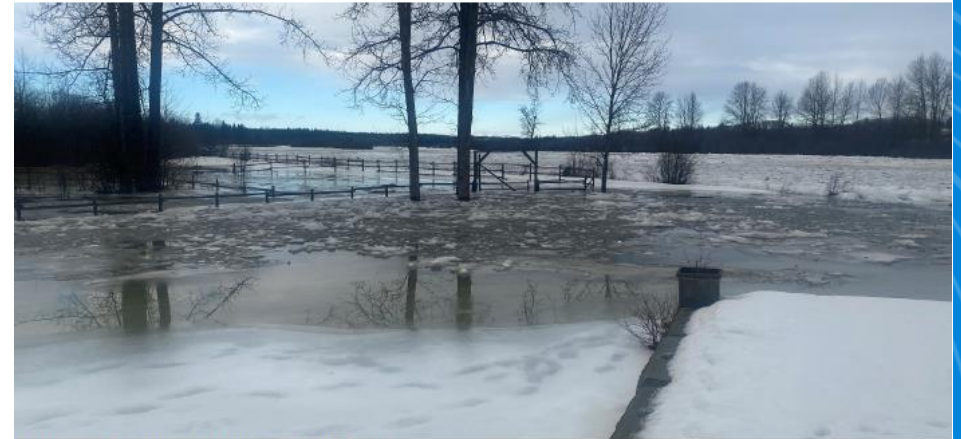
Lastly, the implications of ice dynamics (like the 2021 event) on the movement of gravel and quality of spawning habitat are unknown. While excessive frazil ice and anchor ice may pose a risk to chinook eggs and juveniles living in the substrate (Nechako Fisheries Conservation Program, 2005), local scour and gravel recruitment may be beneficial for white sturgeon given the recognized importance of gravel with clean interstitial spaces for larval survival (McAdam, 2011). Therefore, it would be valuable within the overall context of white sturgeon recovery to assess how the 2021 ice jams altered bed substrate within (or upstream of) the spawning reach.
