Nechako River turbidity June-July 2020

9 July 2020

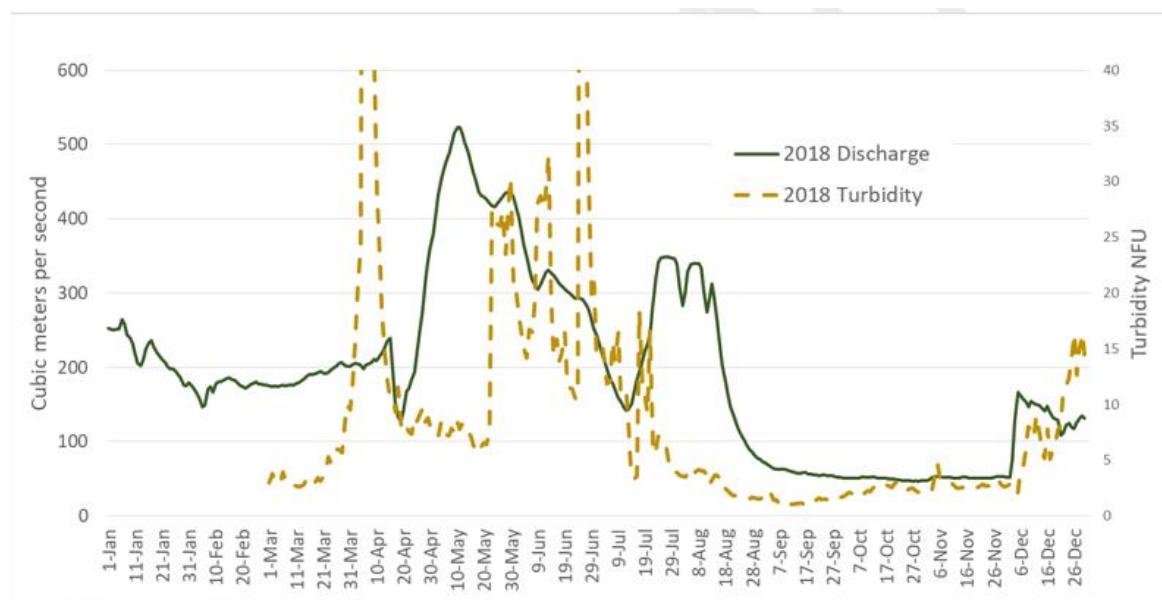
Figure 3 Discharge and turbidity in the Nechako River 2018

Previous investigations into turbidity in the Nechako River indicate that turbidity increases at the onset of spring and in response to an increase in discharge, including at the onset of the Summer Temperature Management Program (Figure 2, Figure 3). Turbidity drops off even if discharge remains high. Increases in turbidity not associated with spillway discharge are assumed to be a response to rainfall events and sediment inputs from tributaries.
