Key Focus

Current Conditions - 24 June 2022

Nechako Reservoir operations update

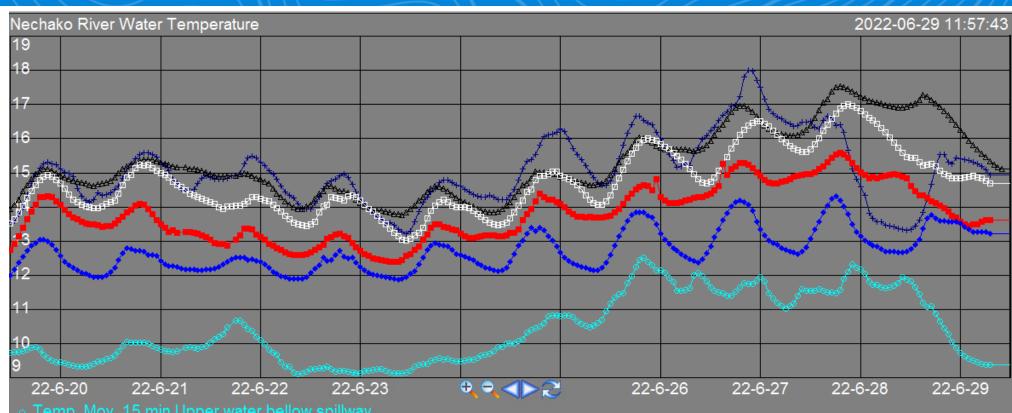
Observed Water Temperatures

- Temp. Moy. 15 min Upper water bellow spillway
- Nechako River below Cheslatta Falls water temperature
- Temp. Moy. 15 min Upper water Fort Fraser
- Nechako River at Vanderhoof water temperature
- △ Temp. Moy. 15 min Upper water Finmoore
- + Nautley River water temperature

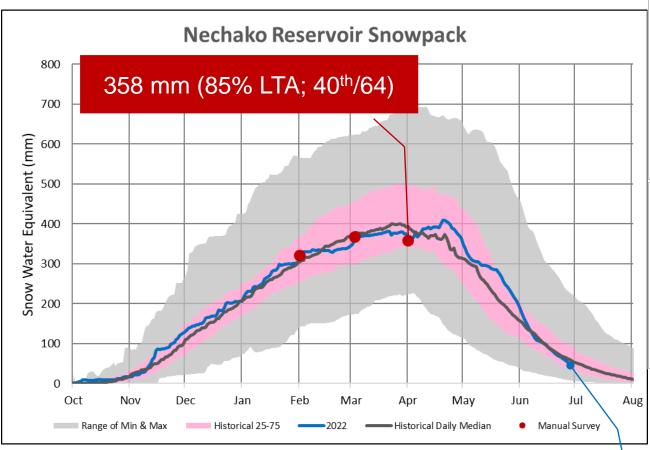
Current Snowpack

Station	Current Value (mm)	LTA* (mm)	%LTA*	Percentile Rank*	
Tahtsa Lake	303	263	115%	68%	
Mount Pondosy	0	7	0%	0%	
Mount Wells	0	1	0%	0%	
* (1992-2021)

600		Automate	ed Show v	Veather S	tation 6	гарп		
500					-			
400								
300		4-		~~~	my my		-	
200			Marine Marine	and of the same		That		
100		ممرير					_	
0	The same of the sa					\ \		
Oct	Nov	Dec J	an Feb	Mar	Apr	May	Jun	Jul

Station	Current Value	%LTA*		
Lu Lake	0	0%		
* (1997-2021)

47 mm (91% LTA; 37th/64)

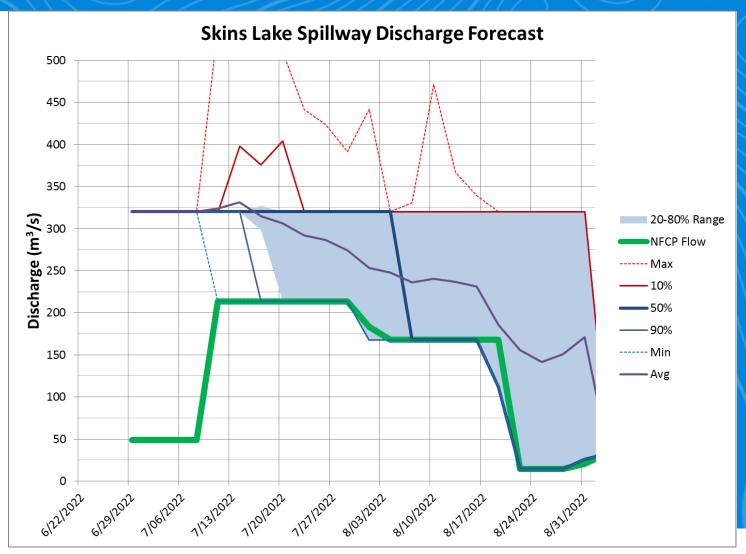
Spillway Management

- SLS discharge is currently at 320 m³/s
- Smelter Re-Start plan integrated
- Flood risk; Murray Cheslatta System 20-25% and Vanderhoof 10-15%

- Skins Lake Spillway is scheduled to be increased to 320 m³/s later today, where it will be maintained for at least a week.
- For real time information and updates visit getinvolvednechako.ca
- To subscribe to weekly updates email us at nechakoreservoirupdates@riotinto.com

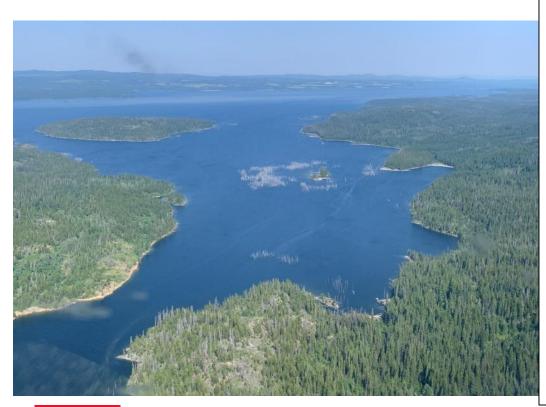
Reservoir Level Projection

Inflow projections are used to estimate reservoir levels over time considering current hydrology and historically observed additional snow and rain.
