MEMORANDUM

TO: Nechako Water Engagement Initiative
FROM: Heidi Regehr, Ph.D., R.P.Bio., Candace Ashcroft, B.Sc., and Jayson Kurtz, B.Sc., R.P.Bio., P.Biol., Ecofish Research Ltd.
DATE: November 2, 2023
FILE: 1316-07

RE: Potential effects of Nechako Reservoir operations on caribou

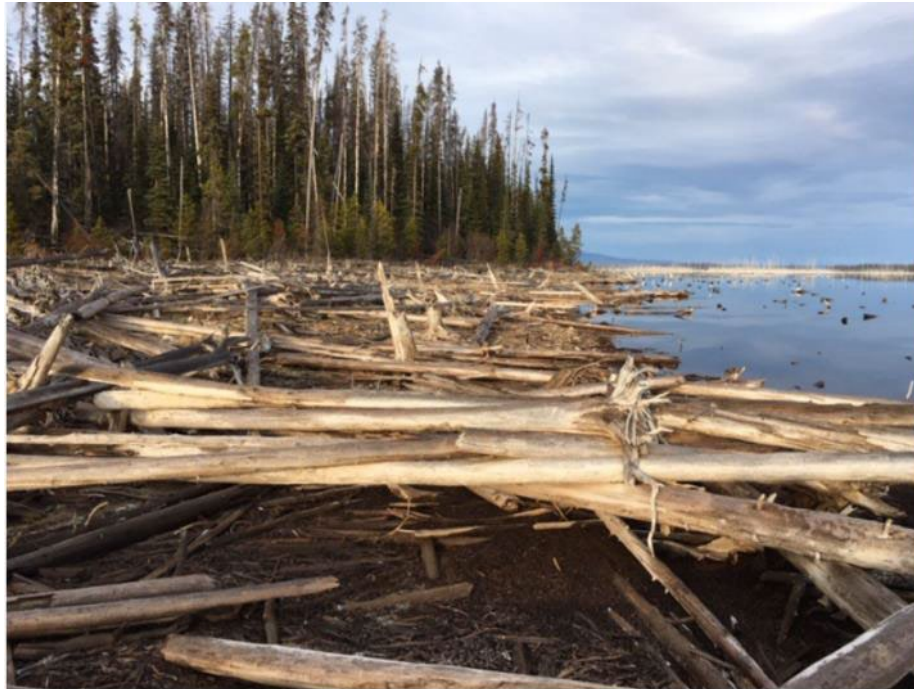
Figure 3. Accumulated shoreline woody debris in Whitesail Reach in 2019 (photo taken from the Society for Ecosystem Restoration in Northern British Columbia (SERNBC) website: <https://sernbc.ca/projects/Whitesail-Reach-Woodland-Caribou-Habitat-Restoration-Project>).

Obstruction of movement due to accumulations of woody debris along reservoir shorelines has been identified as an important potential effect on the TEC subpopulation that is related to reservoir operations. The woody debris (i.e., logs) is generated by trees that were flooded during impoundment of the Nechako Reservoir and that are breaking off, becoming mobile, and accumulating along the shorelines (Figure 3). This woody debris has been documented to be obstructing movement of caribou as they migrate seasonally and when they attempt to access calving islands in Whitesail Lake (Cichowski 2015; Cichowski *et al.* 2020). Observations that woody debris along shorelines impede caribou movements have been confirmed with contemporary telemetry data and local observations, which indicate a reduction in use of the calving islands in Whitesail Reach by caribou over time (1983 to present) (Lee and Flowers 2021). The loss of access to calving islands has the potential to impact calf survival and may impact the viability of the TEC subpopulation (Lee and Flowers 2021). It has also been observed that the rate of accumulation of woody debris has accelerated in recent years, and the risk that the caribou migration route through Whitesail Lake could be abandoned due to movement obstruction is considered high (DWB 2019; Roberts, pers. comm. 2021).

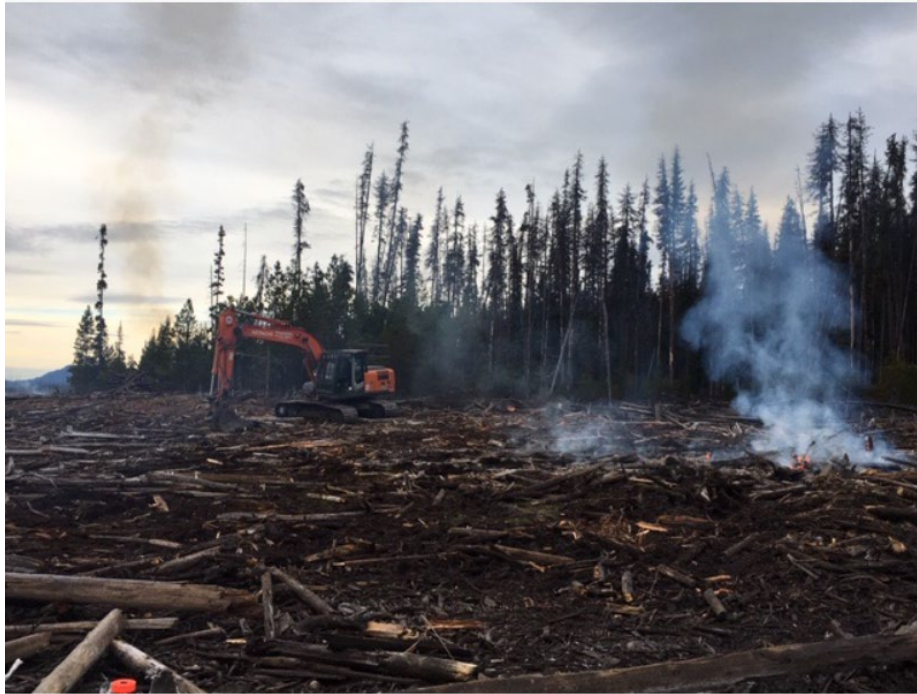
Figure 4. Removal of woody debris within Whitesail Reach in 2019 as part of the Whitesail Reach Woodland Caribou Habitat Restoration Project (photo taken from SERNBC website: <https://sernbc.ca/projects/Whitesail-Reach-Woodland-Caribou-Habitat-Restoration-Project>).

pre- and post-treatment monitoring results to date (Lee and Flowers 2021). Physical works were implemented by the Cheslatta Carrier Nation in 2019 (Figure 4) and involved the removal of woody debris from a total of 500 m of shoreline (~8.67 ha) and the creation of access trails through ~4.60 ha of woody debris in near and foreshore areas. Islands identified as important calving habitat for caribou were selected as candidates and these were ranked according to six criteria: documented caribou use, the amount of area available, debris density, accessibility, proximity to access, and proximity to anthropogenically disturbed areas. Sites with highest ranking were selected for treatment and pre-treatment monitoring, which involved the installation of remote cameras and conducting pre-treatment woody debris transects (drone flights for obtaining high-resolution aerial imagery was also planned but was deferred until 2020). The largest calving island in Whitesail Reach was chosen as the first candidate for shoreline debris removal in 2019. This island was selected because caribou use has been confirmed in the past five years, it has the highest accumulation of woody debris among islands assessed, and it can be easily accessed by barge and heavy machinery (Lee and Flowers 2021). According to the plans presented in the Project Plan and Site Prescriptions report (DWB 2019) and the first monitoring report (Lee and Flowers 2021), the physical works involved:

- Site reconnaissance – inspection of the site for issues that may affect the approach used for debris management, such as presence of sensitive features and requirements for machine work, and preparation of a detailed site plan;
- Clearing and grubbing – selection and creation of designated sites for clearing and grubbing (e.g., for burn piles, timber storage, and piling);
- Mechanized clearing of submerged and emergent standing timber – removal of timber from the nearshore and foreshore of the treatment sites; and
- Disposal of woody debris – woody debris was disposed of by piling and burning.
