MEMORANDUM

TO: Nechako Water Engagement Initiative
FROM: Rachel Chudnow, Ph.D., R.P.Bio., Heidi Regehr, Ph.D., R.P.Bio., and Jayson Kurtz, B.Sc., R.P.Bio., P.Biol., Ecofish Research Ltd.
DATE: September 18, 2023
FILE: 1316-10
RE: Cheslatta Watershed 2022 Fall Reconnaissance Survey – V2

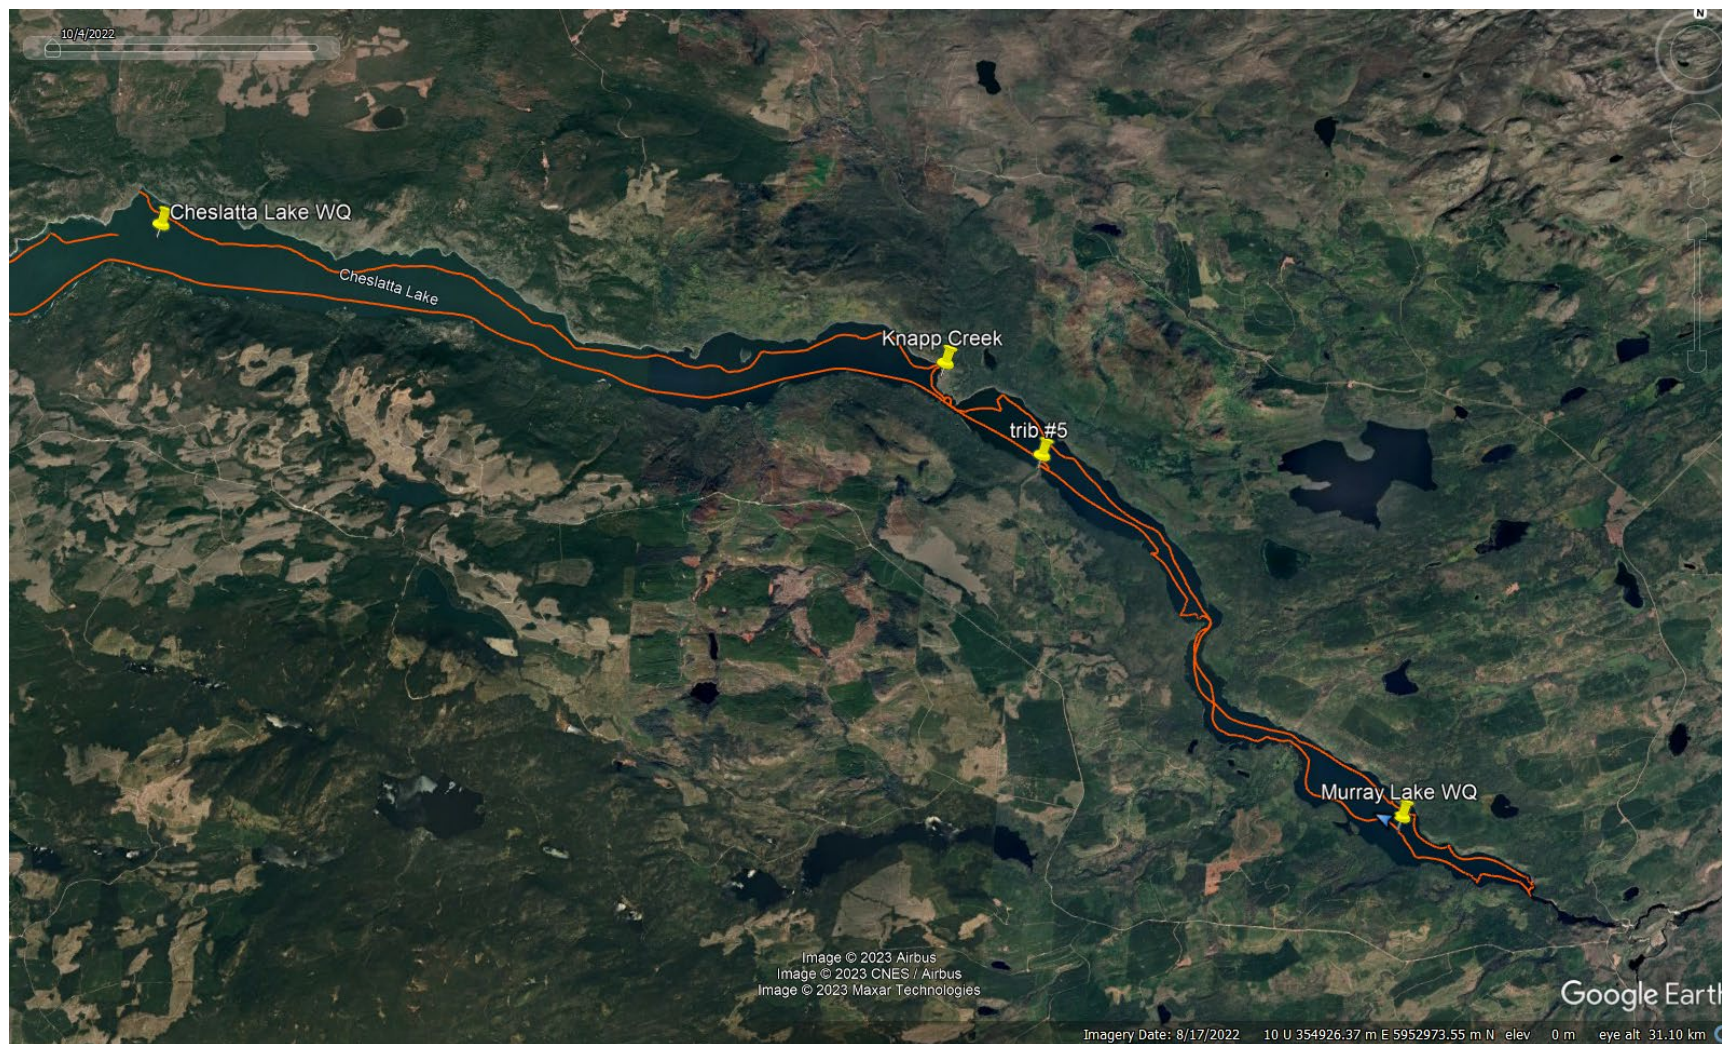
Figure 3. Documented and typical Skins Lake Spillway discharge from January through December 2022 with approximate field survey timing shown by red arrow. Modified from Rio Tinto (2023⁵).

The field survey was conducted on October 4, 2022, during relatively low water levels (i.e., Skins Lake discharge ~40 to 60 cm/s; Figure 3). The survey crew included Jayson Kurtz, Heidi Regehr, and Rachel Chudnow (Ecofish) and vessel operator Cody Reid (Cheslatta Nation Lands and Natural Resources). The north shore of Cheslatta Lake was accessed by vehicle at Cheslatta IR #7 via Hwy 35, the Francois Lake ferry, and several forest service roads; from here, the vessel-based survey fully circumnavigated Cheslatta and Murray lakes (see Map 1, Figure 1, and Figure 2). Most observations were made from the vessel; however, several tributaries, wetlands, and other areas were further investigated from shore. Data collection was primarily qualitative and descriptive (i.e., notes and photos), although some tallies were made (e.g., number of beaver dens). In addition, a single water sample was collected in each lake (Figure 2).

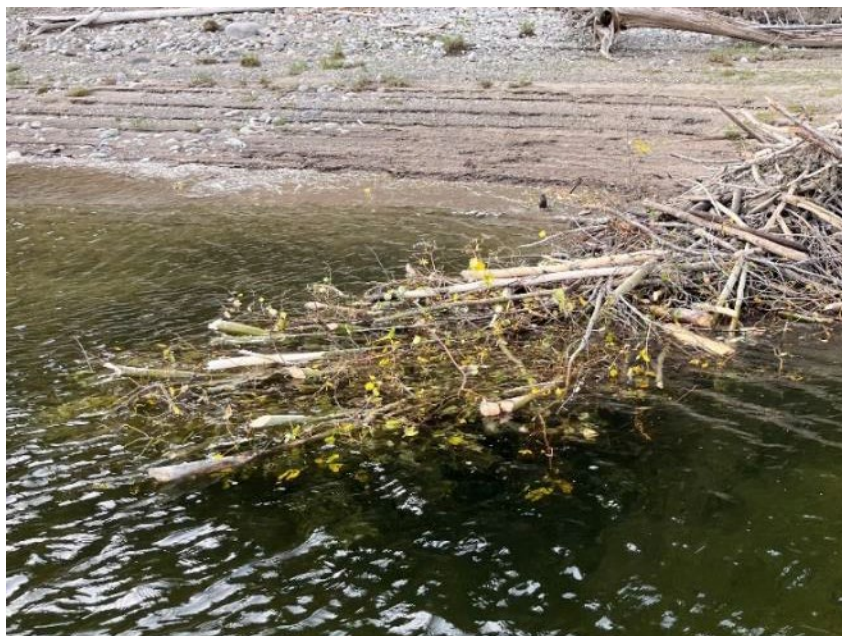
Dens were observed along the shorelines of both Cheslatta and Murray lakes (approximately 15 conical lodges and 36 bank dens observed across the surveyed locations). Den activity varied from inactive to recent/current activity. Vegetation cuttings, trails from riparian habitat to the water edge, and abundant food stored underwater (Figure 4) were observed, as were beavers in several locations.

Figure 4. American Beaver food stored under the water adjacent to bank den on the shoreline of Murray Lake. Photographed on October 4, 2022.

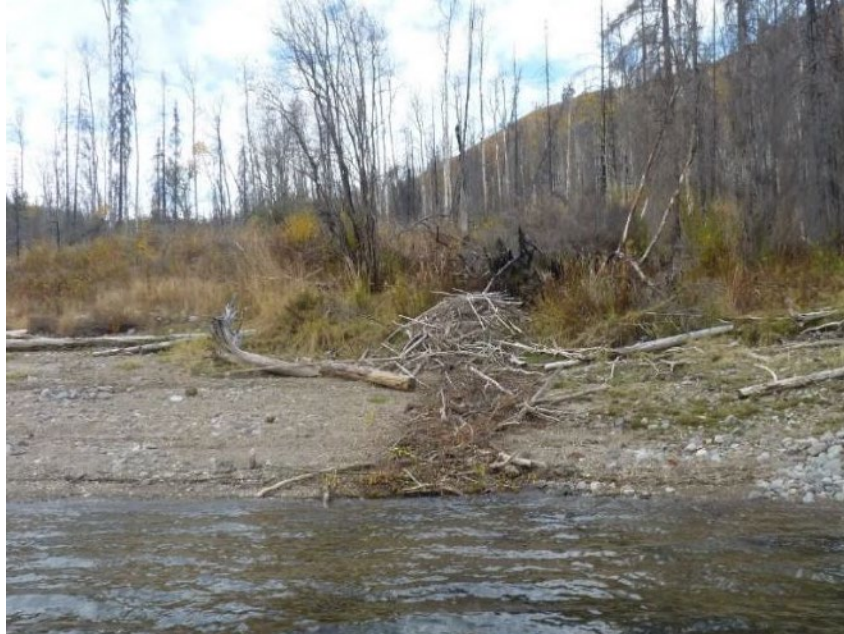
Den size, construction, and elevation above lake water level varied. Several bank dens were vertically oriented, extending up the bank, presumably to accommodate changing water levels (Figure 5). In other cases, dens observed at low elevations along lake shorelines (i.e., that would become inundated at low water levels) appeared to be paired with higher elevation lodges (i.e., that were out of water at the time of survey) or other bank dens (Figure 6). Given the proximity of these dens, it is possible they allow for movement between dens as water levels change.

Figure 5. American Beaver bank den extending vertically up the bank of Cheslatta Lake. Photographed on October 4, 2022.

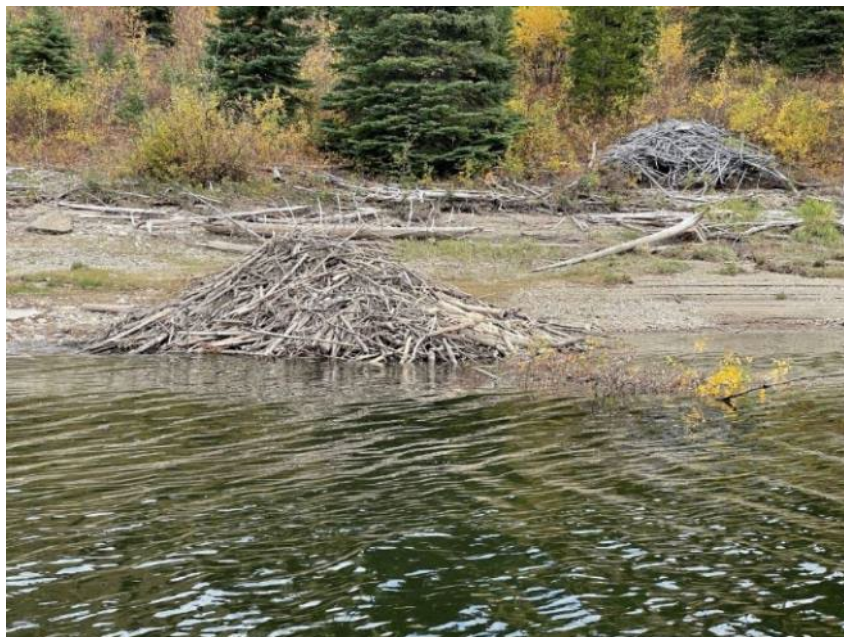
Figure 6. Low and high water American Beaver conical lodges on the north shore of Murray Lake. Photographed on October 4, 2022.

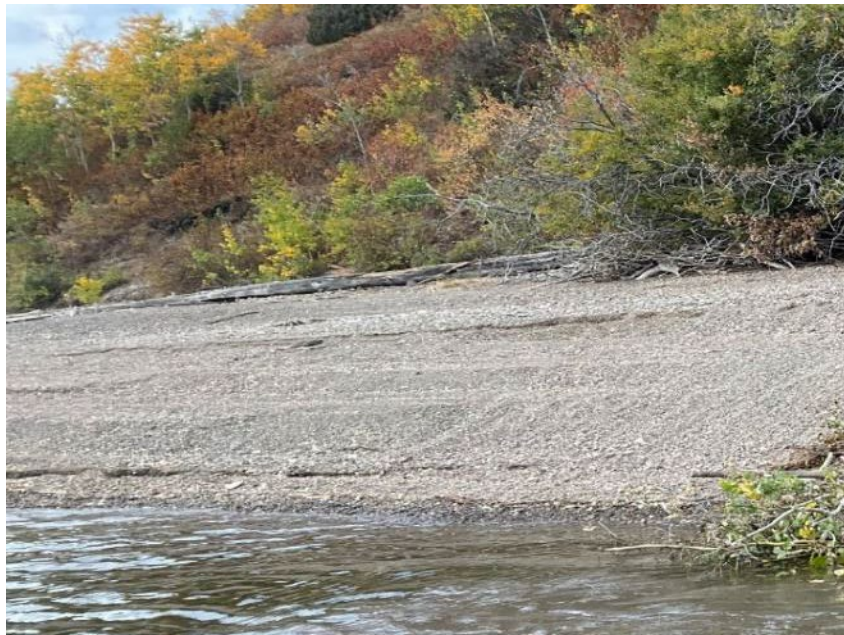
Shoreline erosion was observed throughout both Cheslatta and Murray lakes (Figure 7, Figure 8, Figure 9). Erosion was primarily between high and low water levels (Figure 7), but higher bank erosion was also intermittently present, and more prevalent along the eastern end of Murray Lake (Figure 8, Figure 9). Extensive erosion was observed along the visited portions of Cheslatta River including bank erosion (Figure 10) and channel bar erosion/deposition (Figure 11).

Figure 7. Erosion along the shoreline of Cheslatta Lake. Photographed on October 4, 2022.

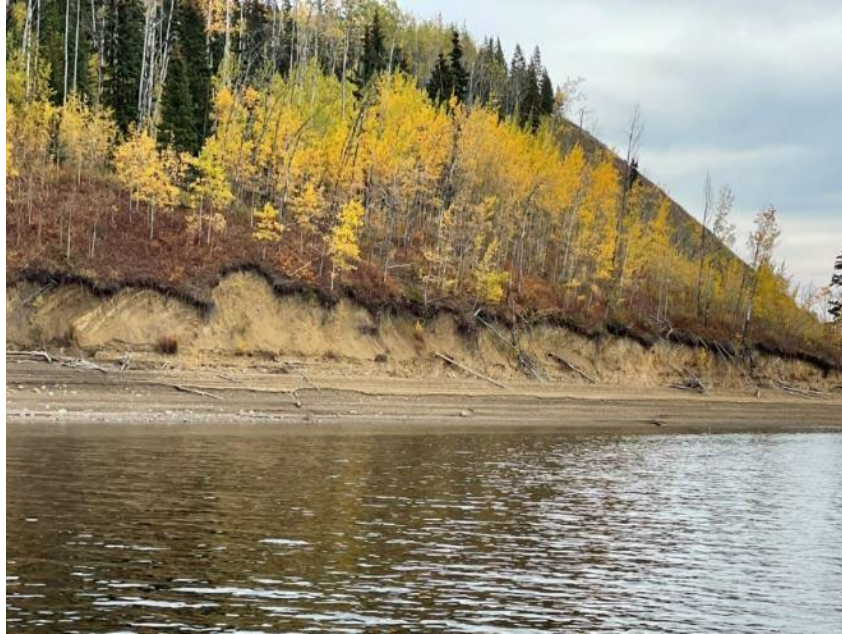
Figure 8. Erosion along the eastern shoreline of Murray Lake. Photographed October 4, 2022.

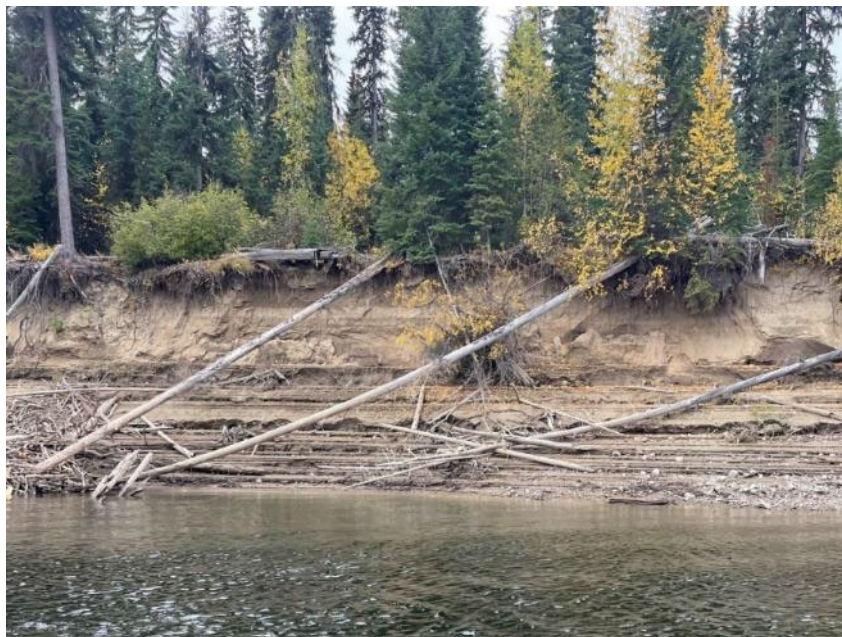
Figure 9. Erosion along the eastern shoreline of Murray Lake. Photographed October 4, 2022.

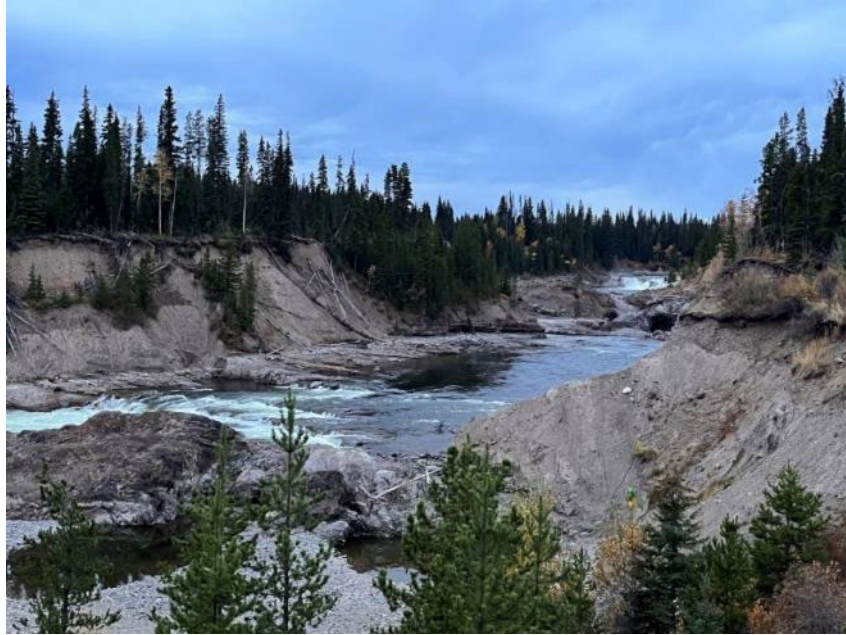
Figure 10. Eroded banks of the Cheslatta River. Photographed on October 4, 2022.

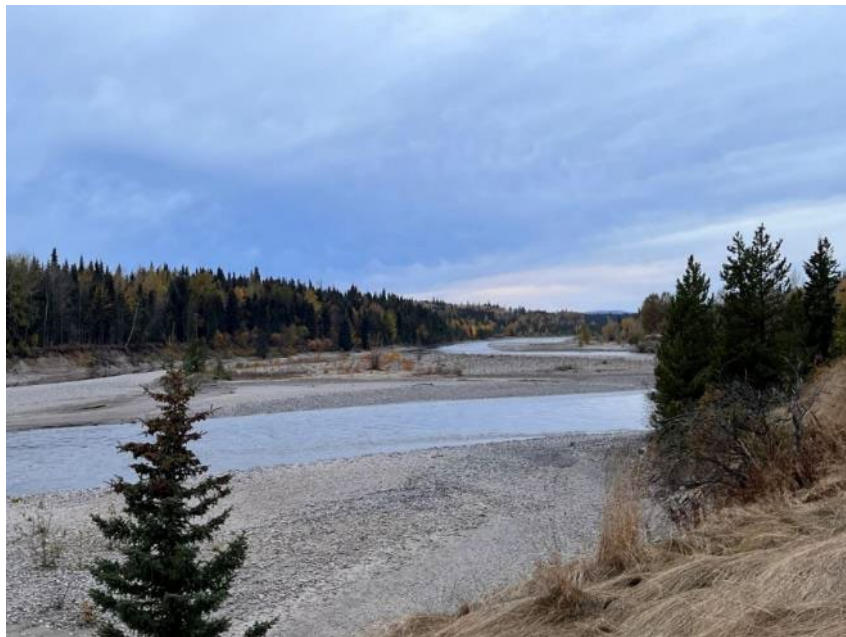
Figure 11. Wide and shallow channel of the Cheslatta River. Photographed on October 4, 2022.

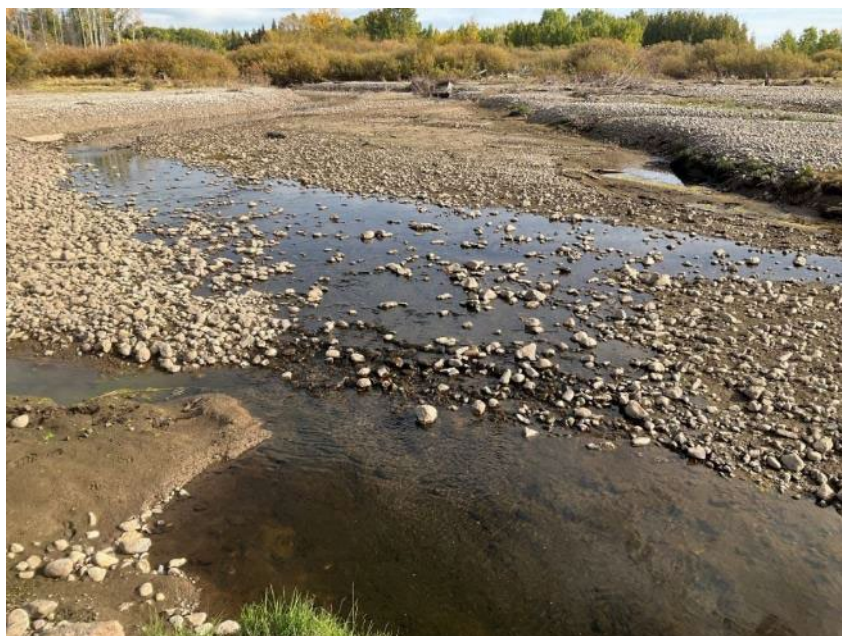
The field crew visited six tributaries to assess connectivity (i.e., fish passage) with Cheslatta and Murray lakes (Table 1, see Figure 1 and Figure 2 for map of tributary locations). No fish access issues, as the result of water regulation (i.e., due to exposed barriers, woody debris, or vegetation encroachment in the foreshore) were observed. However, fish access was restricted (and in some cases completely prevented) at the time of survey due to low (see Figure 12) or no tributary flow (Figure 13). Additional tributary confluence photos are provided in Appendix A.

Figure 12. Low flow at the mouth of Knapp Creek. Photographed on October 4, 2022.

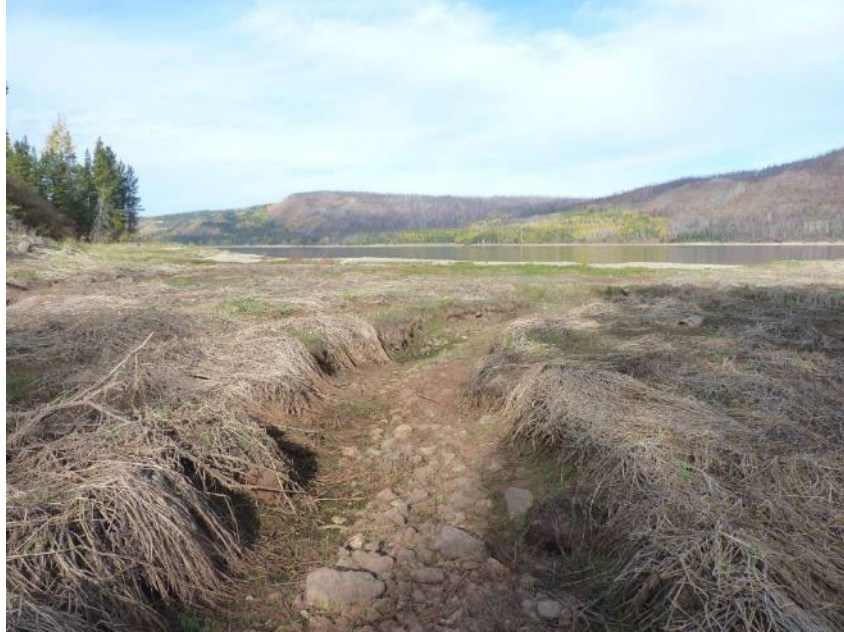
Figure 13. No flow at the mouth of unnamed tributary #5. Photographed on October 4, 2022.

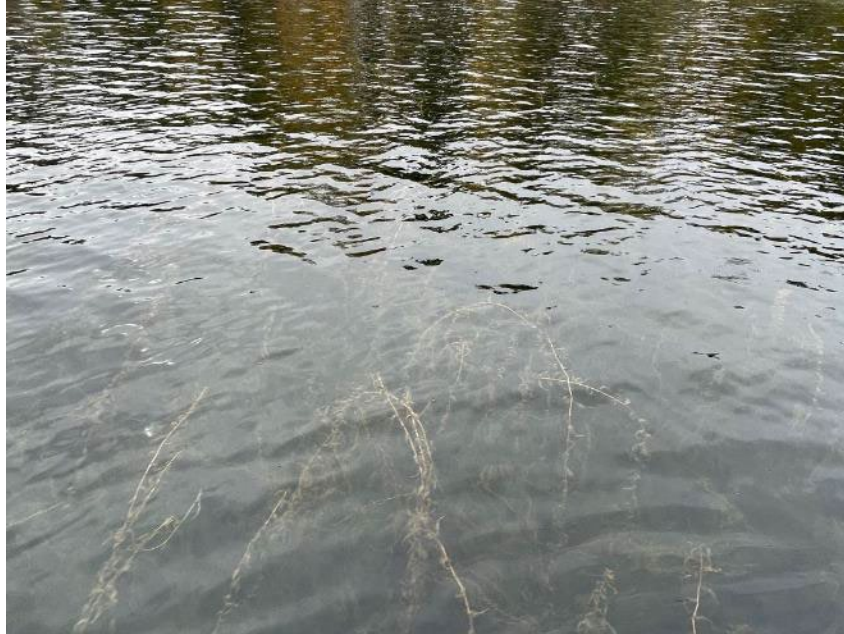
Figure 14. Aquatic vegetation (*Potamogeton* spp.) observed along Cheslatta Lake and Murray Lake shorelines. Photographed on October 4, 2022.

During the field survey, aquatic vegetation (*Elodea*, *Potamogeton* spp. and others) were observed at several locations (Figure 14, Figure 15). Water quality sampling results, including temperature depth profiles, Secchi disk readings, and laboratory analysis results are included in Appendix B.

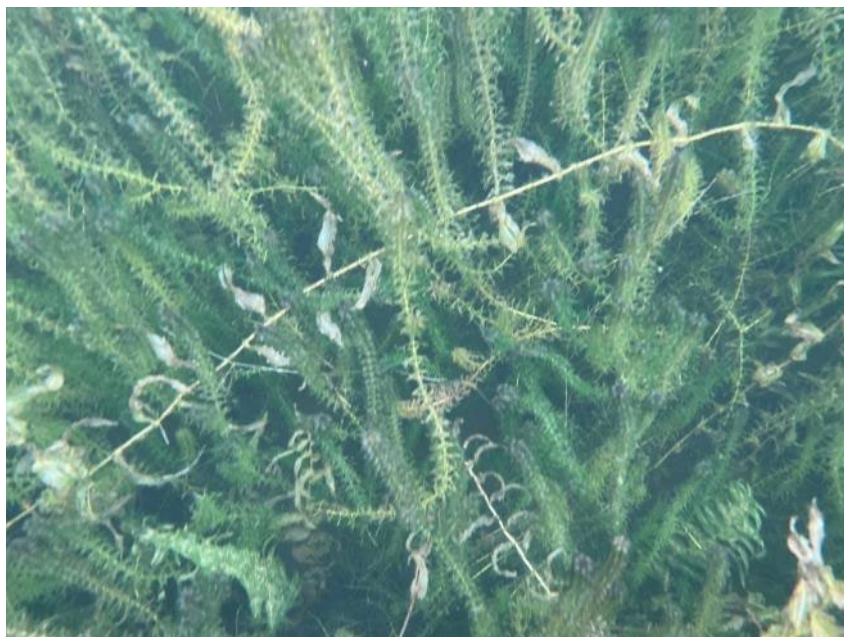
Figure 15. Aquatic vegetation (*Elodea* and *Potamogeton* spp.) observed along Cheslatta Lake and Murray Lake shorelines. Photographed on October 4, 2022.

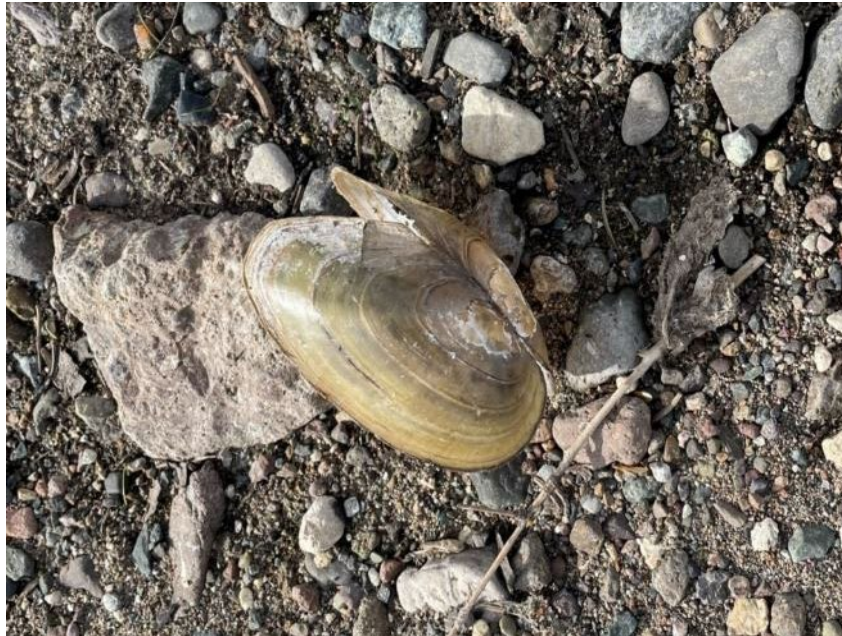
Figure 16. Freshwater mussel shell observed on the shoreline of Cheslatta Lake near unnamed tributary #5. Photographed on October 4, 2022.

Freshwater mussel shells (Western Floater, *Anodonta kennerlyi*; Figure 16) were observed along the beach at several locations in both Cheslatta and Murray lakes. No live mussels were observed.

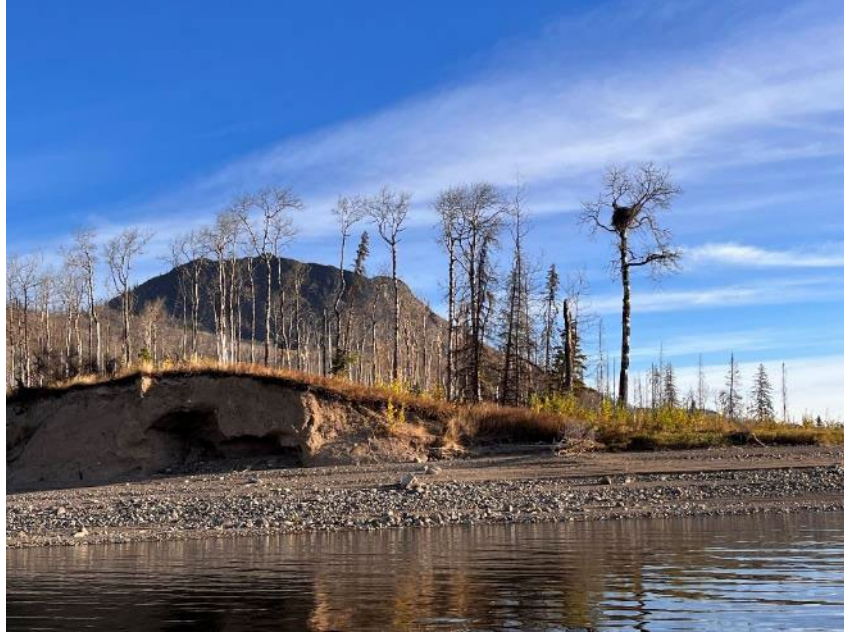
Figure 17. Bald Eagle nest on the north shoreline of Cheslatta Lake. Photographed on October 4, 2022.

- Bald Eagle (*Haliaeetus leucocephalus*) nests were observed at several locations on the north shore of Cheslatta Lake (Figure 17). All nests were located well above the high watermark.
- Large flocks of waterfowl were observed near the Cheslatta River fan/confluence with Cheslatta Lake, and along the shoreline/wetland area between Cheslatta and Murray lakes.
- No Osprey (*Pandion haliaetus*) nests were seen.

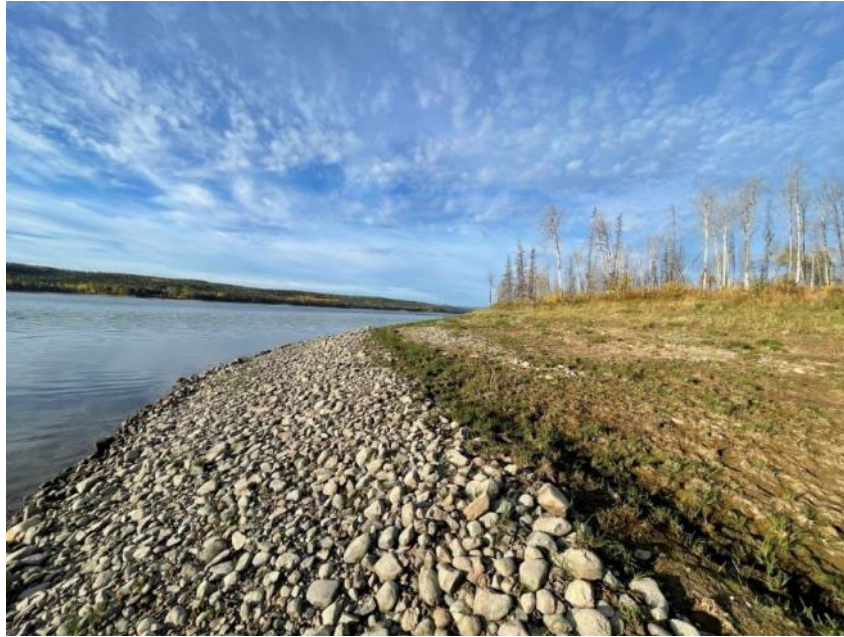
Minimal riparian vegetation was observed along the foreshore of Cheslatta and Murray lakes, which was dominated by exposed gravel/cobble beaches (Figure 18, Figure 19). Some exceptions included flat benches colonized by flood-tolerant vegetation near the reservoir/upland interface (Figure 20).

Figure 18. Exposed gravel/cobble beach with minimal vegetation in the foreshore of the northern shoreline of Cheslatta Lake near unnamed tributary #2. Photographed on October 4, 2022.

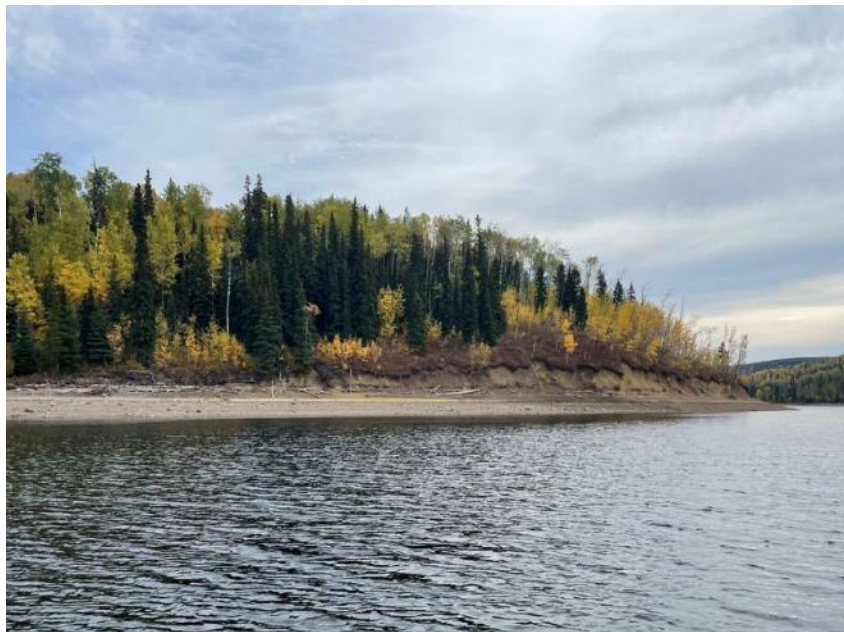
Figure 19. Exposed gravel/cobble beach in the foreshore on the northern shoreline of Cheslatta Lake, with intact riparian and upland vegetation communities beyond the foreshore. Photographed on October 4, 2022.

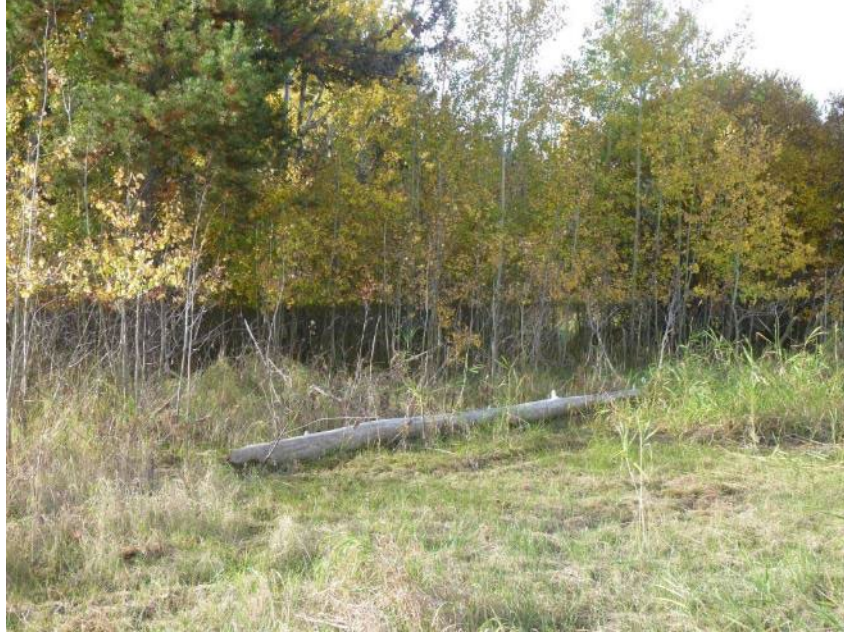
Figure 20. Riparian vegetation adjacent to Cheslatta Lake. Photographed on October 4, 2022.

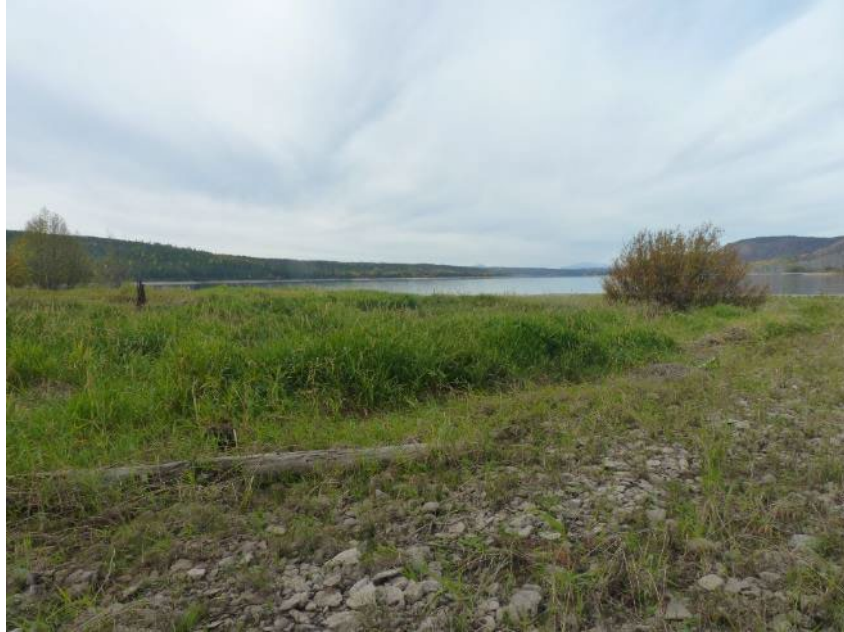
Figure 21. Flood-tolerant wetland vegetation within the foreshore of Cheslatta Lake near unnamed tributary #5. Photographed on October 4, 2022.

Generally, little wetland habitat was identified within the foreshore of Cheslatta and Murray lakes. Where wetland habitat was observed (Figure 21, Figure 22, Figure 23), it was often located behind beaches or berms with exposed substrate (Figure 24). Some of these areas were not wetted at the time of the field survey but were expected to be at higher water levels. Identified wetland areas may support some amphibian breeding and bird nesting that could be directly or indirectly affected by water management.

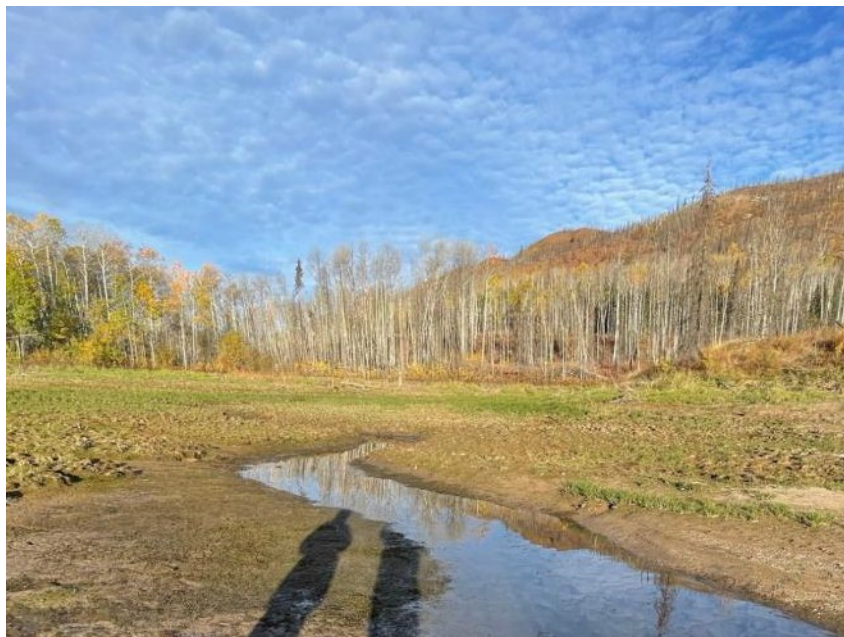
Figure 22. Wetland area surrounding unnamed tributary #2, located on the northern shore of Cheslatta Lake. Photographed on October 4, 2022.

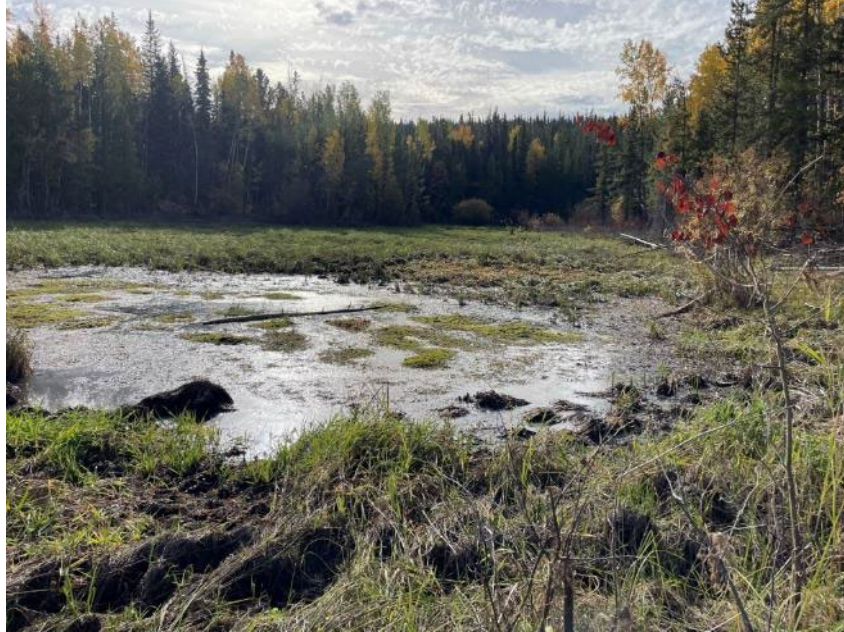
Figure 23. Wetland observed along the south shore of Cheslatta Lake at unnamed tributary #4. Photographed on October 4, 2022.

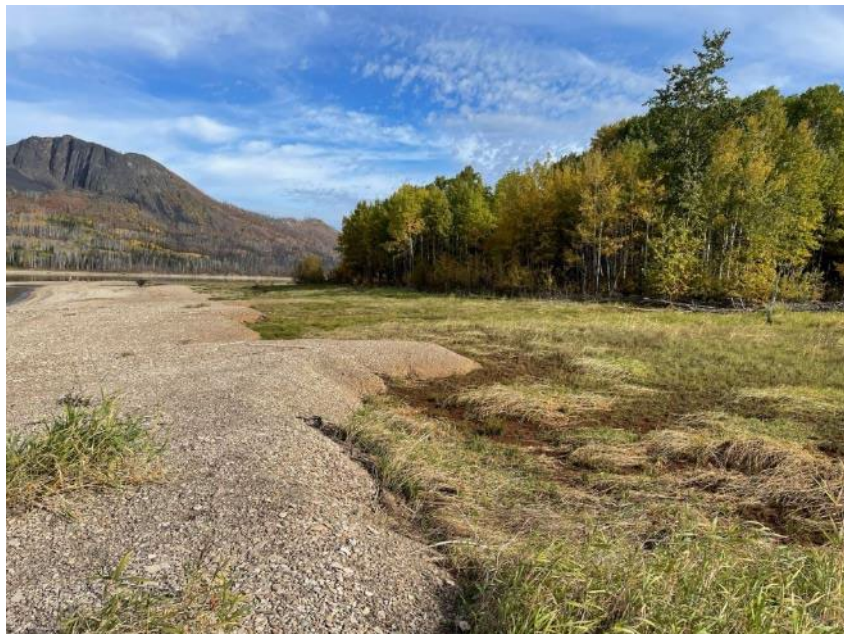
Figure 24. Wetland vegetation located behind a gravel beach berm along the shoreline of Cheslatta Lake, just west of unnamed tributary #5. Photographed on October 4, 2022.

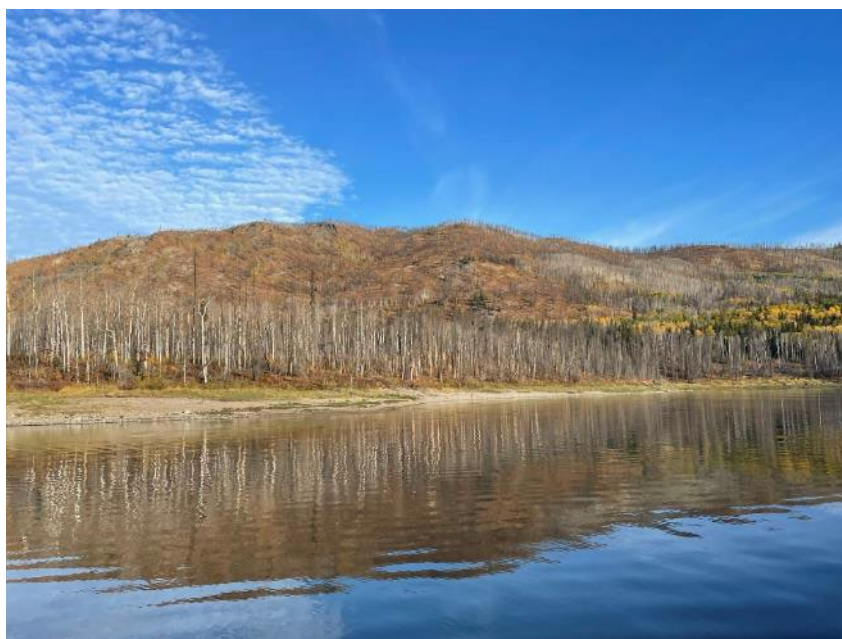
Wildlife use of the foreshore and immediate upland area was evident; an adult female black bear and single cub were observed on the north shore of Murray Lake, and numerous bear, ungulate, small mammal, and bird tracks were observed along both lake shorelines. Cheslatta and Murray lake shorelines were gently sloping (Figure 25) and where steep banks were observed, they were frequently intersected with more moderate slopes where animal access would be relatively easy within a small spatial scale (Figure 26).

Figure 25. Gently sloping shoreline of Cheslatta Lake. Photographed on October 4, 2022.

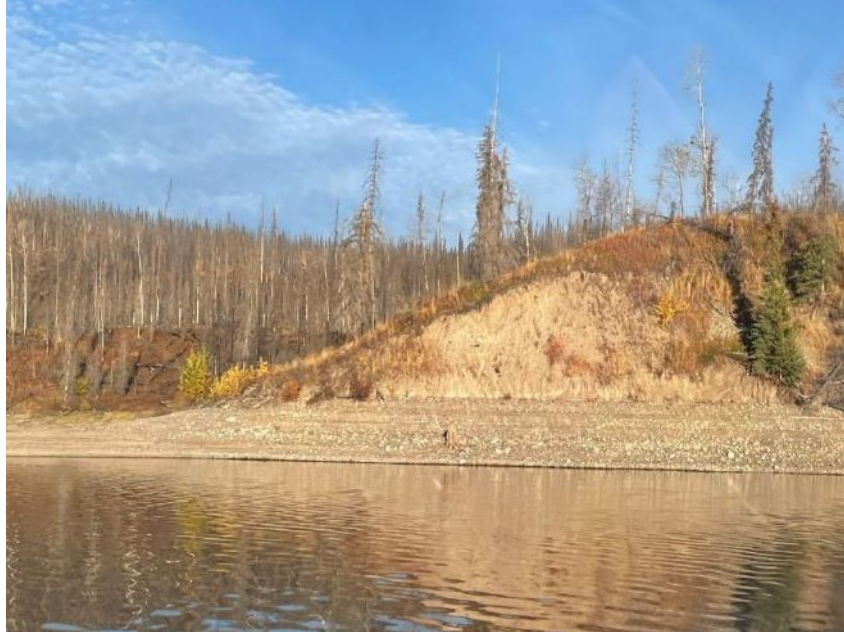
Figure 26. Steep, eroded bank intersected with lower gradient area on the northern shoreline of Cheslatta Lake. Photographed on October 4, 2022.

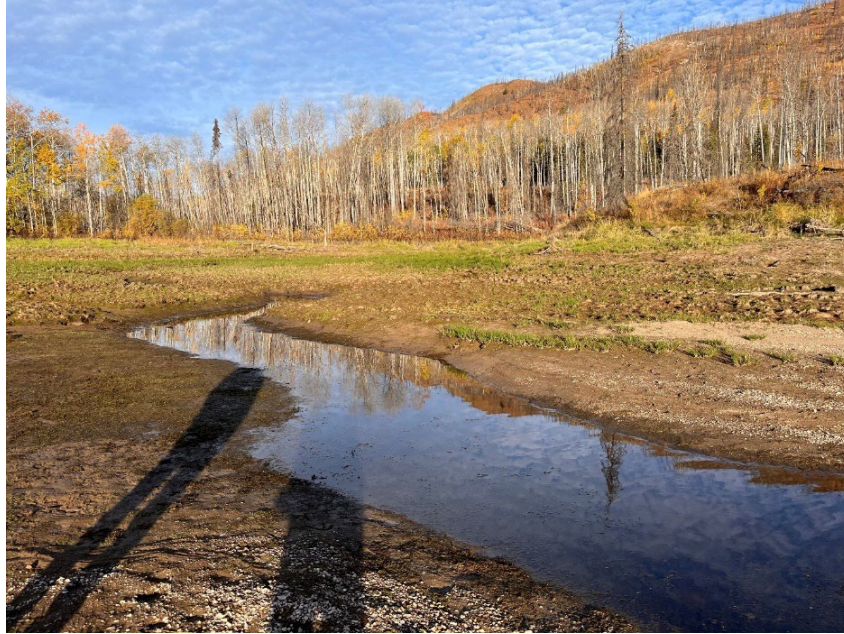
Figure 27. Looking upstream at unnamed tributary #1, located on the northern shore of Cheslatta Lake. Photographed on October 4, 2022.

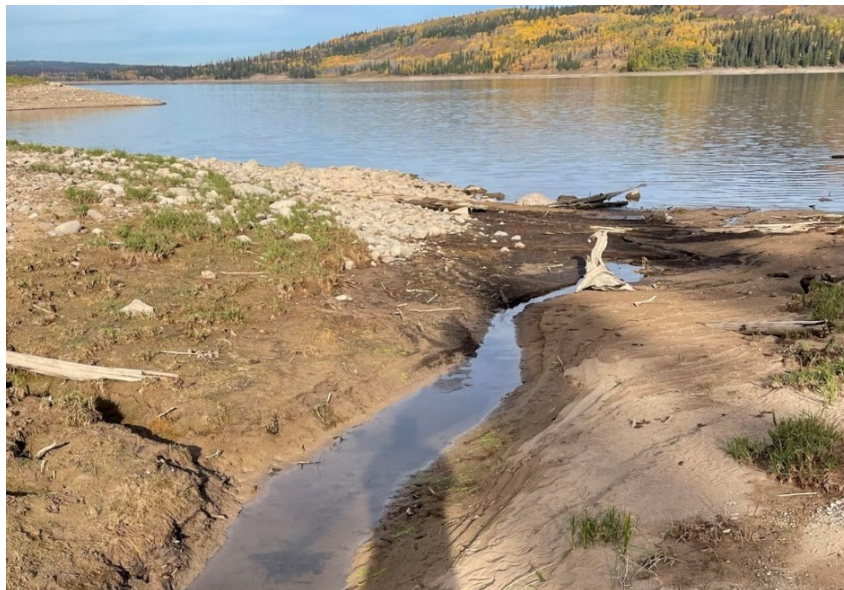
Figure 28. Looking downstream at the partially dewatered mouth of unnamed tributary #2 on the southern shore of Cheslatta Lake. Photographed on October 4, 2022.

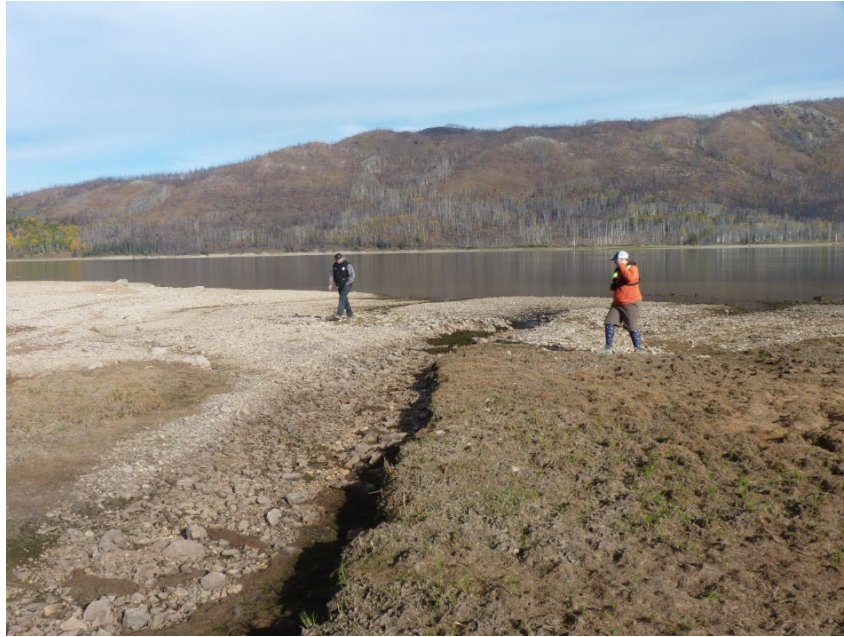
Figure 29. Looking downstream at the partially dewatered mouth of unnamed tributary #3, located on the southern shore of Cheslatta Lake. Photographed on October 4, 2022.

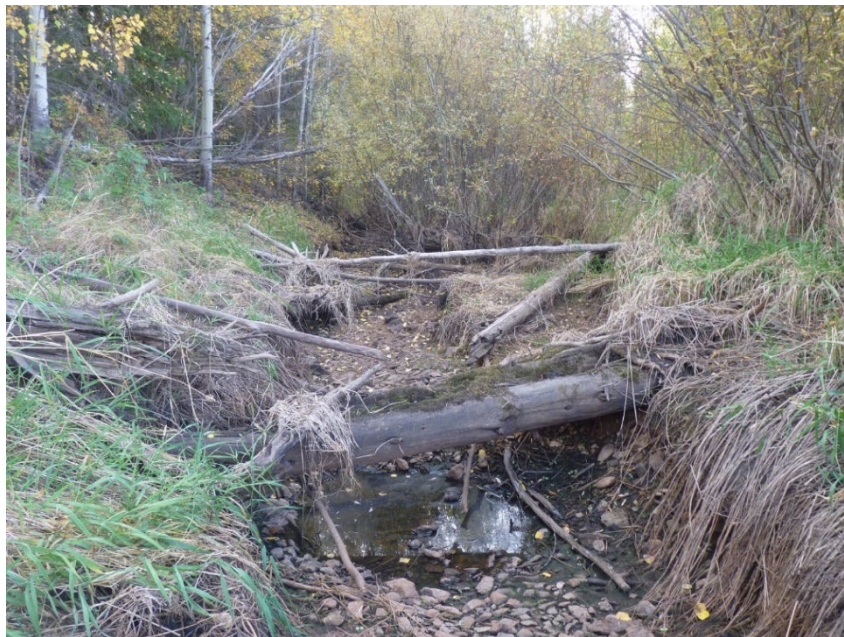
Figure 30. Looking upstream at a dewatered portion of unnamed tributary #3, located on the southern shore of Cheslatta Lake. Photographed on October 4, 2022.

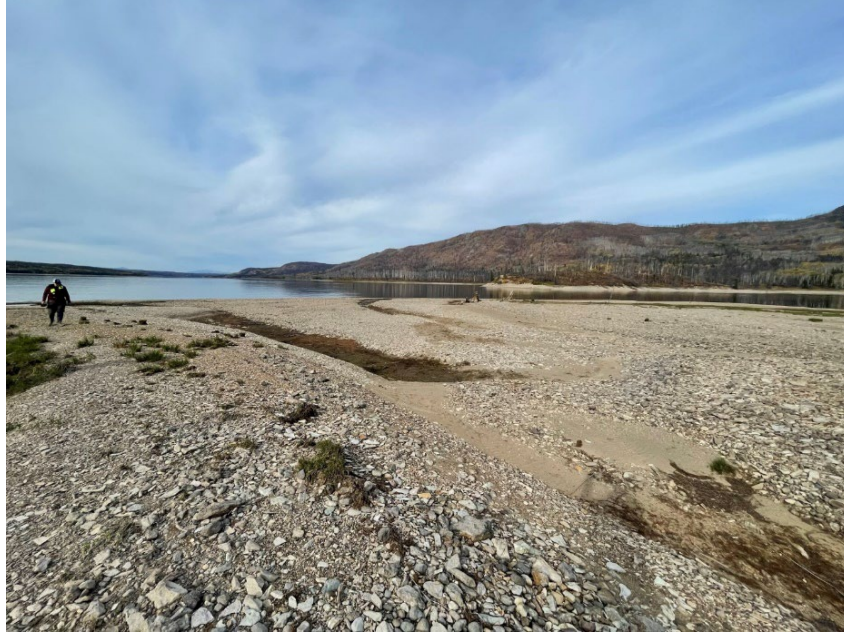
Figure 31. Looking downstream at unnamed tributary #4. Photographed on October 4, 2022.

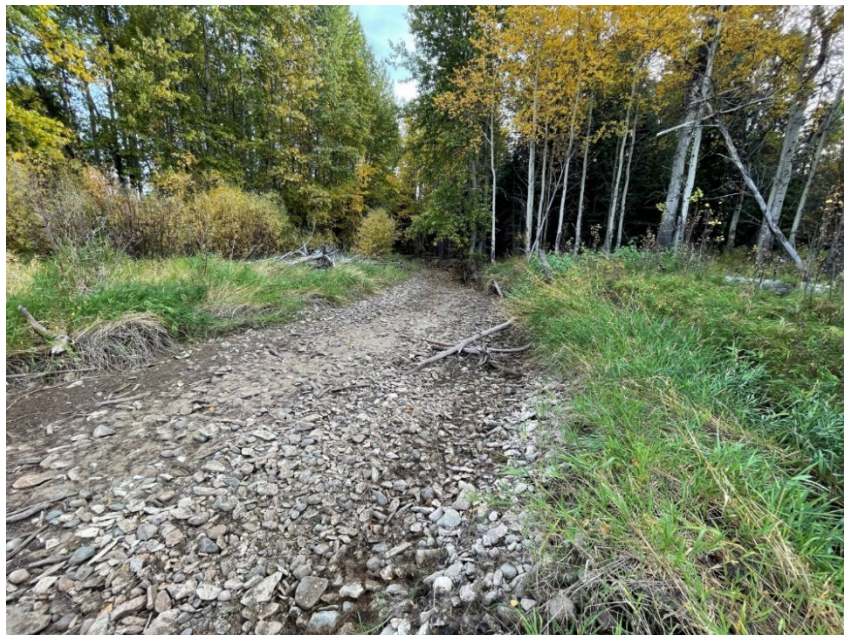
Figure 32. Looking upstream at unnamed tributary #4. Photographed on October 4, 2022.

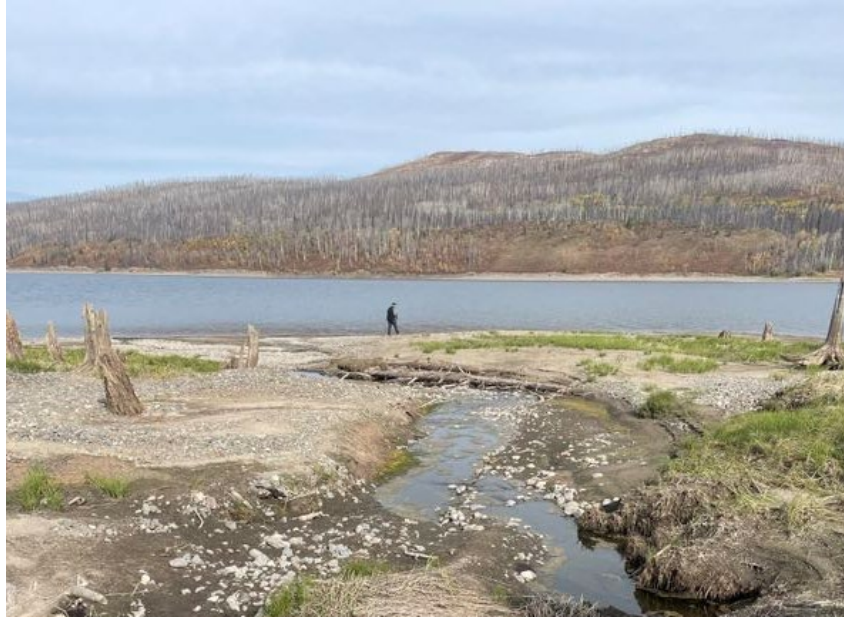
Figure 33. Looking downstream at the mouth of unnamed tributary #5. Photographed on October 4, 2022.

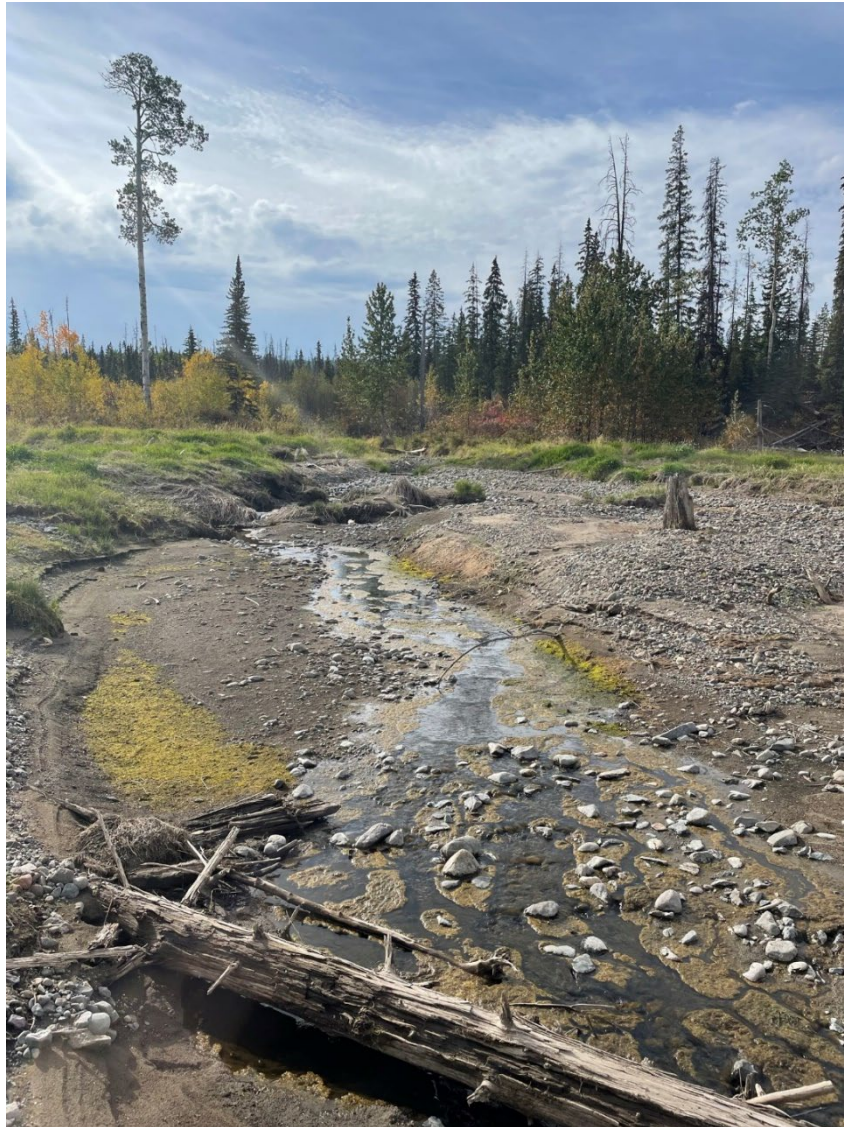
Figure 34. Looking upstream at unnamed tributary #5. Photographed on October 4, 2022.

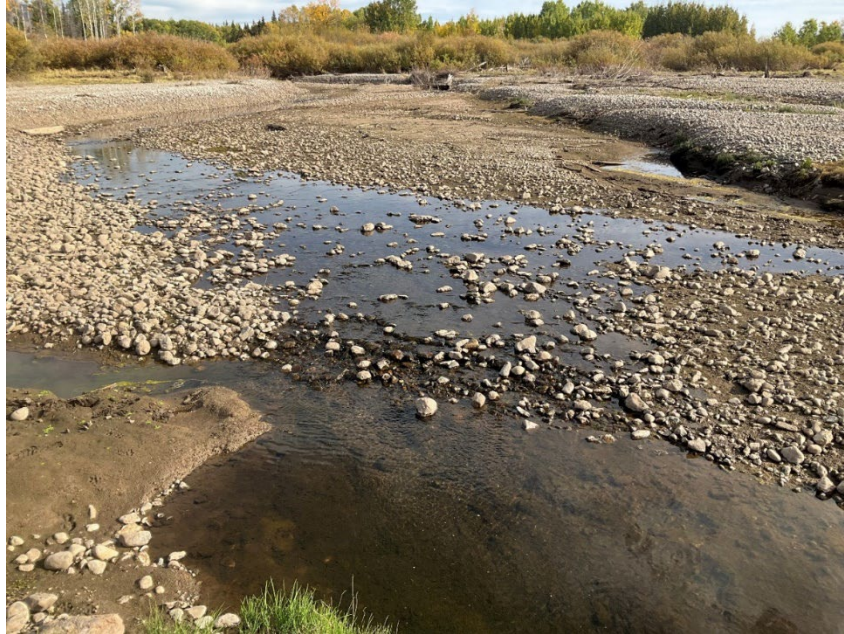
Figure 35. Looking upstream at the mouth of Knapp Creek. Photographed on October 4, 2022.

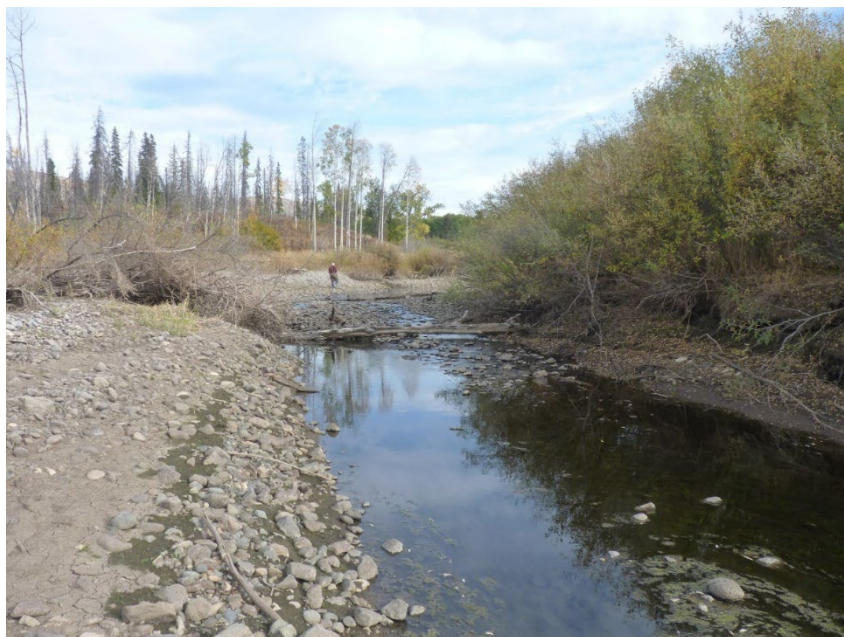
Figure 36. Knaff Creek immediately upstream of the confluence with Cheslatta Lake. Photographed on October 4, 2022.
