MEMORANDUM

TO: Nechako Water Engagement Initiative
FROM: Steve Nicholl, B.Sc., R.P.Bio., Noel Swain, M.Sc., R.P.Bio., Jennifer Carter, M.R.M., R.P.Bio., Matthew Sparling, M.Sc., and Adam Lewis, M.Sc., R.P.Bio., Ecofish Research Ltd.
DATE: December 15, 2022
FILE: 1316-07
RE: Nechako River Fish Stranding Screening Assessment

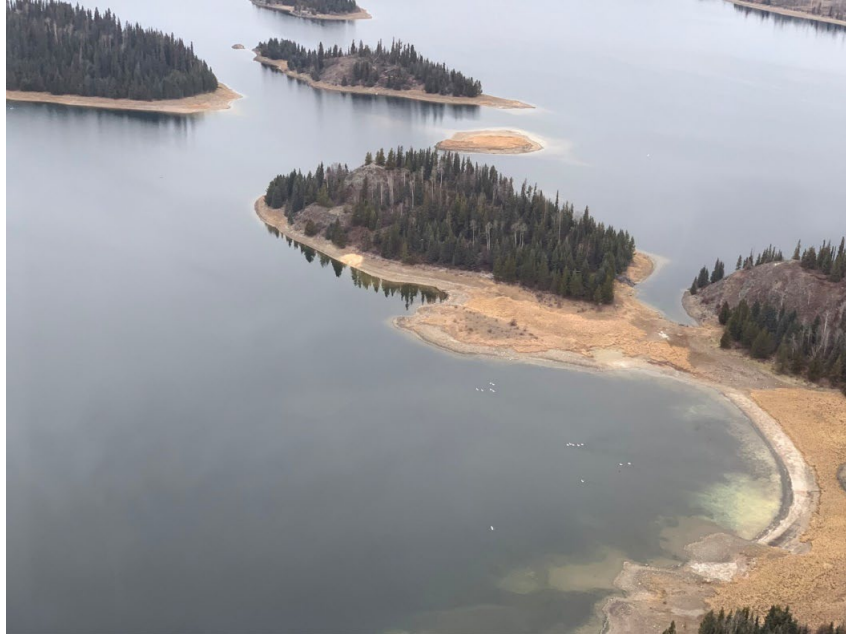
Figure 1. Aerial photographs of Skins Lake shoreline taken on November 21, 2019 showing low-gradient, stranding-sensitive shoreline habitat.

The Cheslatta River extends from the Skins Lake Spillway downstream for 1.5 km to Skins Lake, providing fish rearing and holding habitat and possibly spawning habitat. Skins Lake provides littoral and pelagic lake habitat of 512 ha with a maximum depth of 21.0 m (Hatfield 1998). The Cheslatta River then continues downstream of Skins Lake, providing approximately 23 km of riverine habitat until its confluence with Cheslatta Lake, which provides approximately 3,500 ha of littoral and pelagic lake habitat with a maximum depth of 73 m (Golder 2005). Review of satellite imagery of Skins Lake and the Cheslatta River shows high-risk stranding habitat exists (i.e., low gradient banks, extensive gravel/cobble bar formations, and side channels, Figure 1 and Figure 2).

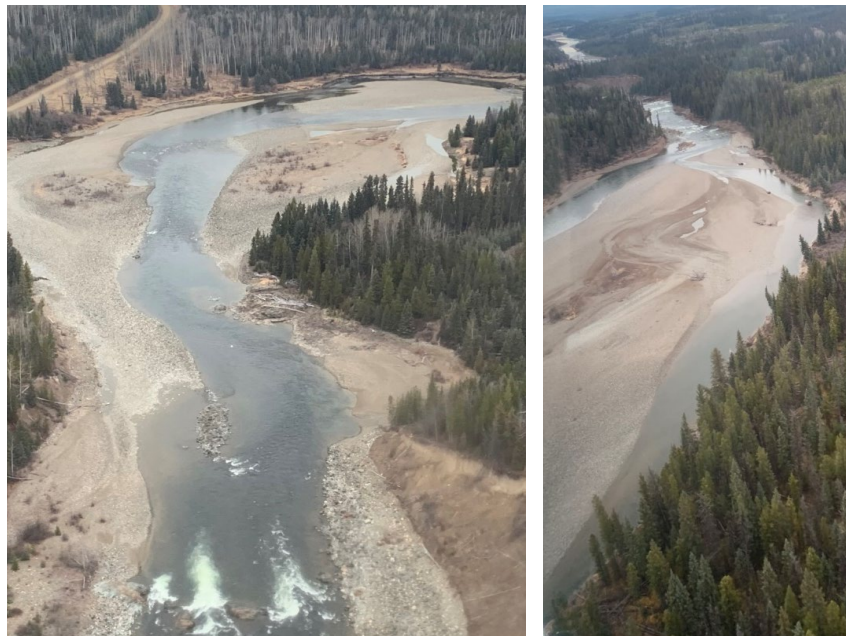
Figure 2. Aerial photographs of upper Cheslatta River shoreline taken on November 21, 2019 showing stranding-sensitive low-gradient banks, gravel bars, and side channel habitat.

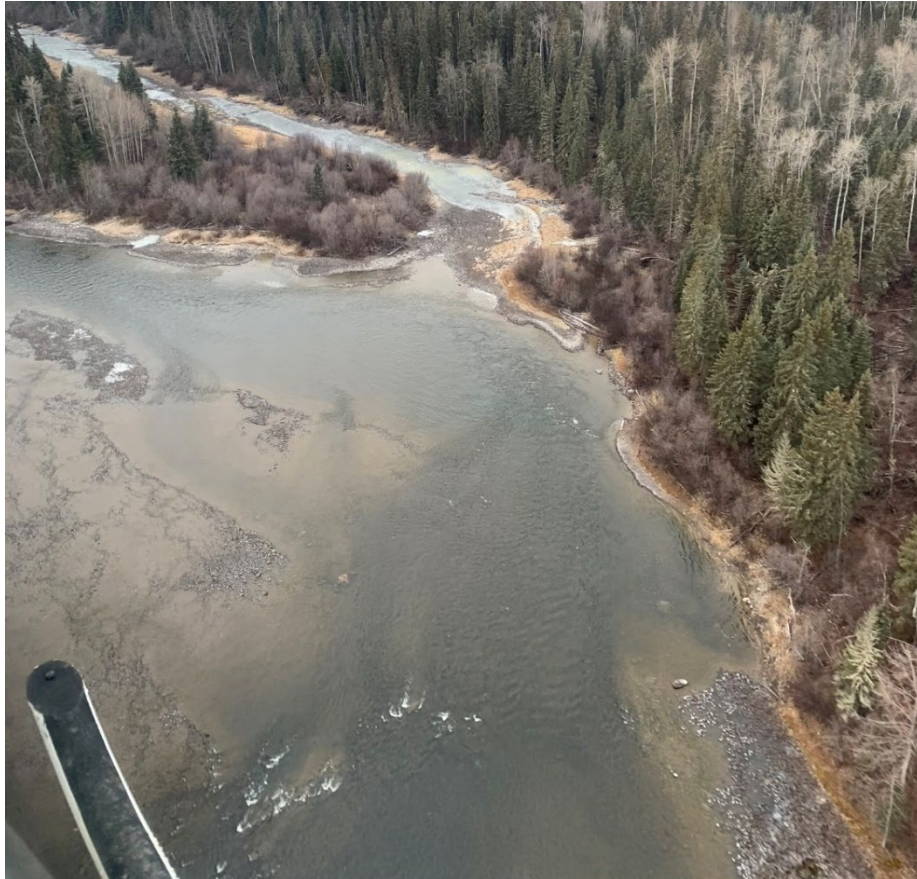
Figure 3. Aerial photographs of Nechako River shoreline taken on November 21, 2019 showing stranding-sensitive low-gradient banks, gravel bars, and side channel habitat.

Fish species may be affected by flow reductions during all life stages; however, juvenile forms are at greater of stranding due to their slow swimming speed, tendency to hide in cover, and use of shallow habitats at risk of dewatering. The Nechako River has extensive high stranding risk habitats (e.g., low-gradient banks, extensive gravel/cobble bar formations, and side channels; Figure 3).

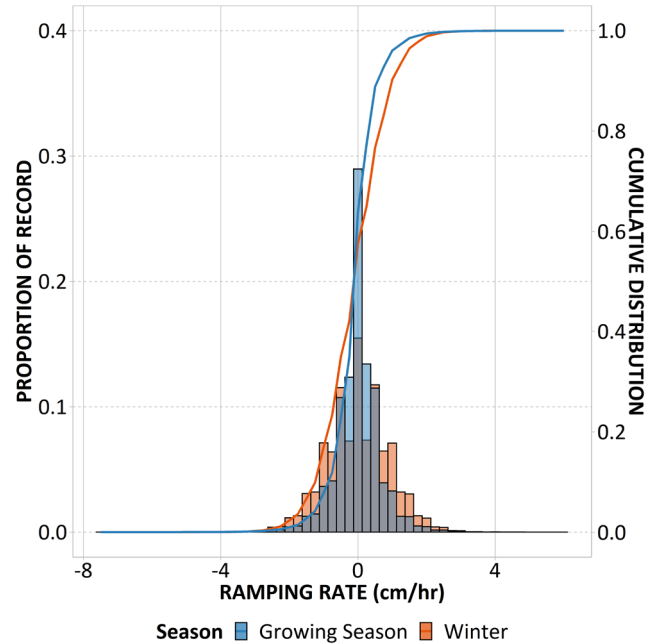
Figure 9. Frequency of ramping rates by season at the west end of Cheslatta Lake (WSC JA018) from 2012 to 2020.

Ramping rates in Cheslatta Lake and the Nechako River are low and within generic standard ramping rates identified for hydroelectric projects (Catthcart 2005) >99% of the time. Down-ramping rates exceed -2.5 cm/hr rate 0.367% of the time in Cheslatta Lake, and only 0.036% of the time in the Nechako River (Table 2). Plots of ramping rates by season are provided in Figure 9 to Figure 12. In Cheslatta Lakes both down-ramping and up-ramping rates increase in the winter months, likely a result of the influence of ice cover, whereas in the Nechako River ramping rates are higher in the summer, reflecting the influence of seasonal peak flows.

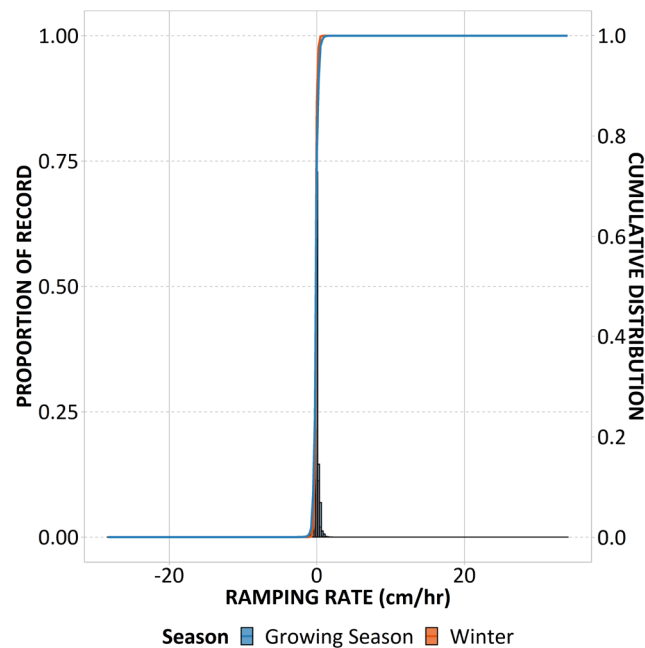
Figure 10. Frequency of ramping rates by season in the Nechako River below Cheslatta Falls (WSC JA0017) from 2012 to 2020.

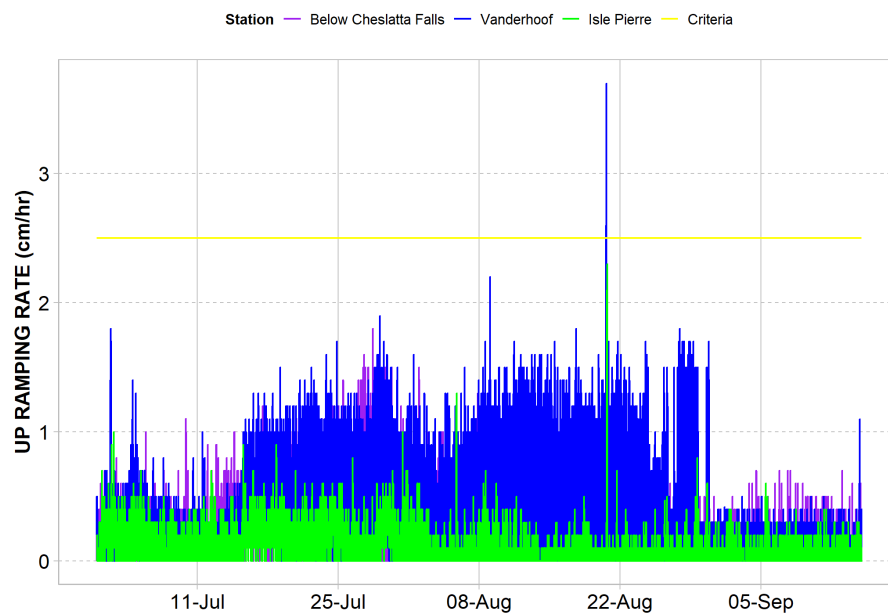
Figure 16. 2020 up-ramping rates (cm/hr) during STMP flow release period as measured at gauges located below Cheslatta Falls, at Vanderhoof and Isle Pierre.

Down-ramping and up-ramping rates from 2012 to 2020 during the STMP period for gauges located below Cheslatta Falls are plotted in Appendix A. Exceedances were infrequent and generally of short duration (15-60 minutes), with a maximum of 8 events observed in a single year (at Cheslatta Lake) but fewer down-ramping events in the Nechako River (four Below Cheslatta Falls, one at Vanderhoof, and none at Isle Pierre).
