# Rio Tinto Water Engagement Initiative

## Nechako River Erosion

### Final Report, Rev. 2

April 19, 2024  
Final Report, Rev. 2  
NHC Reference 3006714

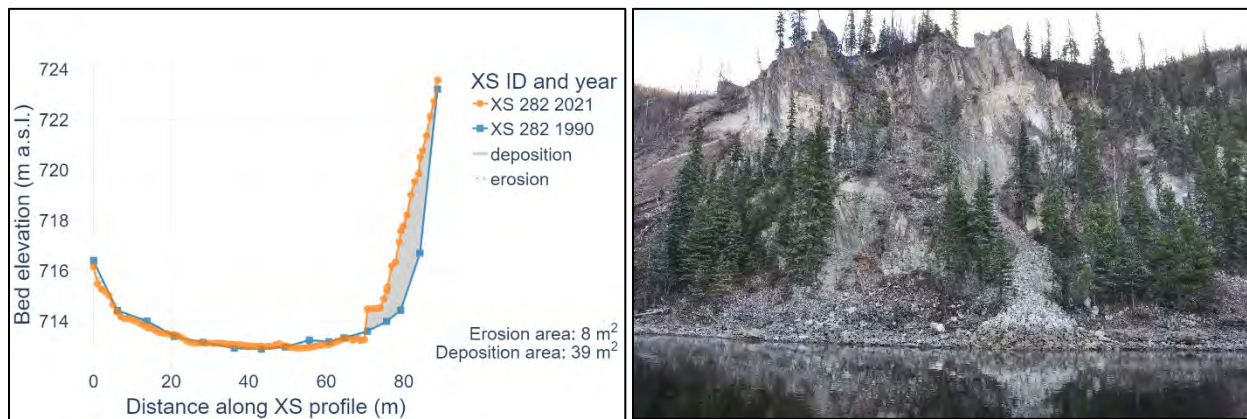
**Figure 4.2** Sediment input from the valley wall and associated channel fill along the right bank at XS 282 (1990-2021).

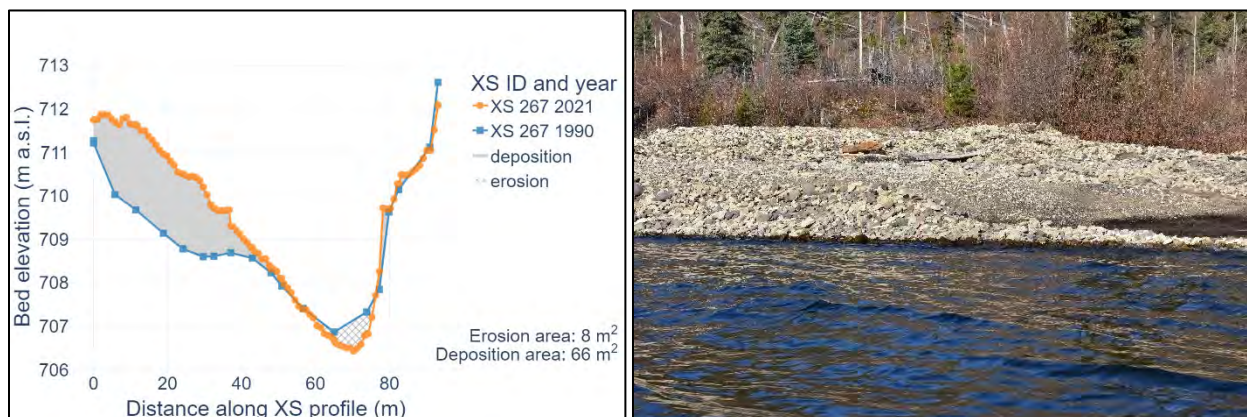
**Figure 4.3** Tributary sediment input causing localized deposition and fill along the left bank at XS 267 (1990-2021).

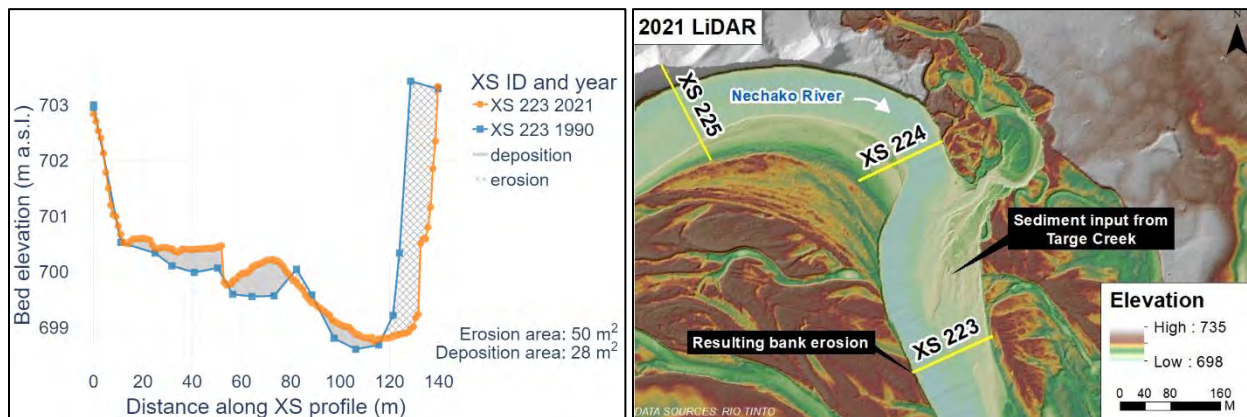
**Figure 4.8** Sediment input from Targe Creek pushing the mainstem of the Nechako River into the opposite bank at XS 223 (1990-2021); note that a cross-channel distance of 0 m on the transect plot corresponds to the left bank of the Nechako River.

However, a considerable amount of lateral erosion has occurred at XS 223, located immediately downstream of the confluence with Targe Creek, where sediment input from the creek is depositing in the form of an alluvial fan, redirecting the flow of the Nechako River towards the opposite bank (Figure 4.8). In addition to gravel inputs from Targe Creek, the ongoing bank erosion also appears to be contributing gravels to the channel (Photo 4.1).

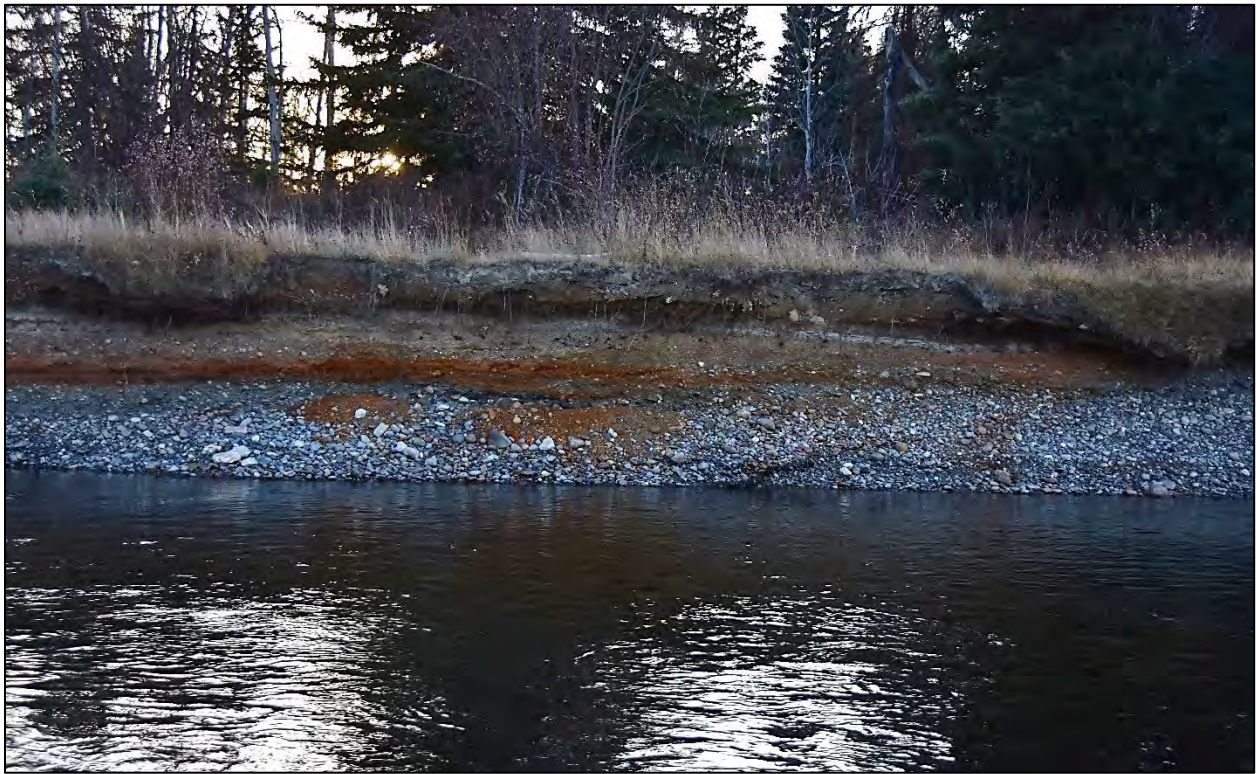
**Photo 4.1** Gravel input to the Nechako River from right bank erosion at XS 223.

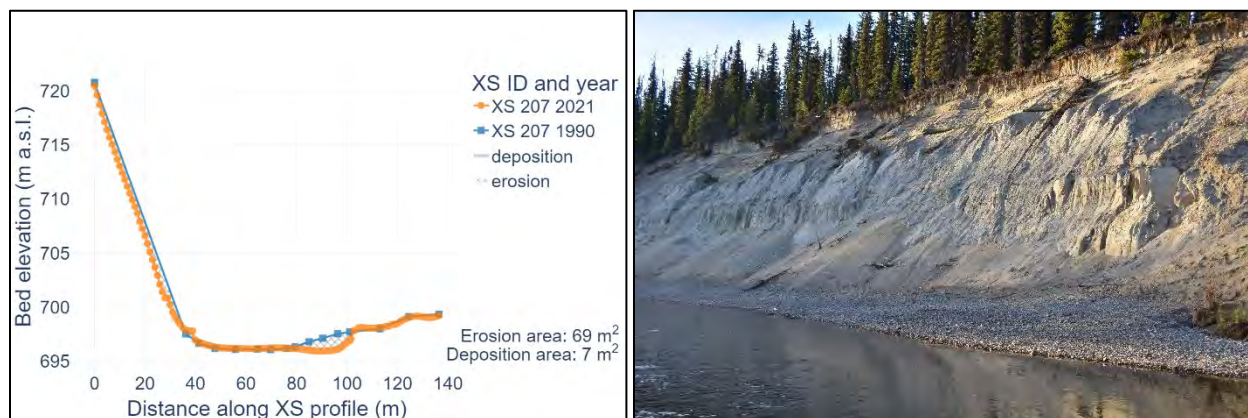
**Figure 4.11 Minor erosion of the high cutbank at XS 207 (1990-2021).**

In contrast to the cutbank between XS 217 and XS 215, a considerable amount of lateral erosion has occurred along, and especially downstream of, the third cutbank located between XS 208 and XS 206. While the upstream portion of this meander at XS 208 has remained stable over time, some lateral erosion of the high cutbank has occurred throughout the middle section of the meander at XS 207 (Figure 4.11). Immediately downstream of the high glaciolacustrine terrace, at XS 206, the channel has eroded into lower elevation floodplain deposits as the river has migrated laterally by approximately 30 m (Figure 4.12).

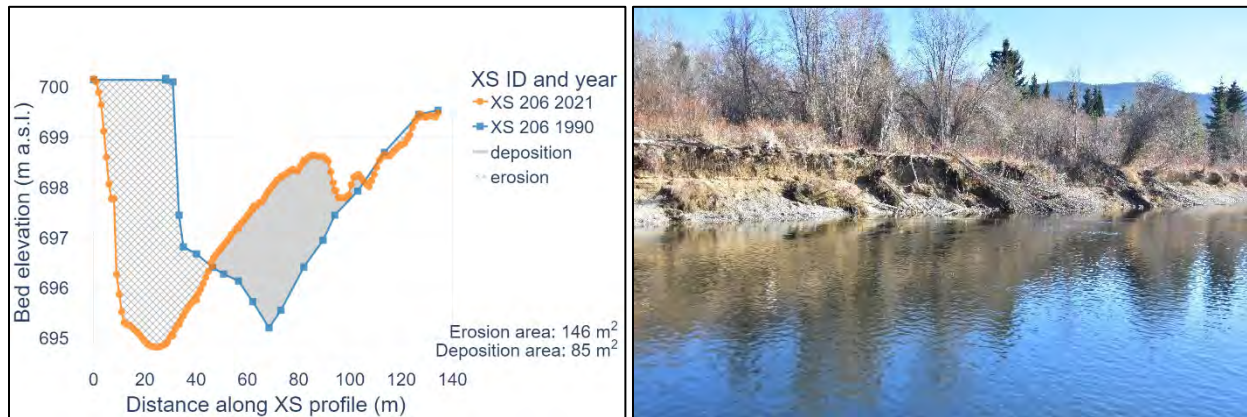
**Figure 4.12 Approximately 30 m of lateral channel migration into the floodplain observed at XS 206 located immediately downstream of a high glaciolacustrine terrace (1990-2021).**

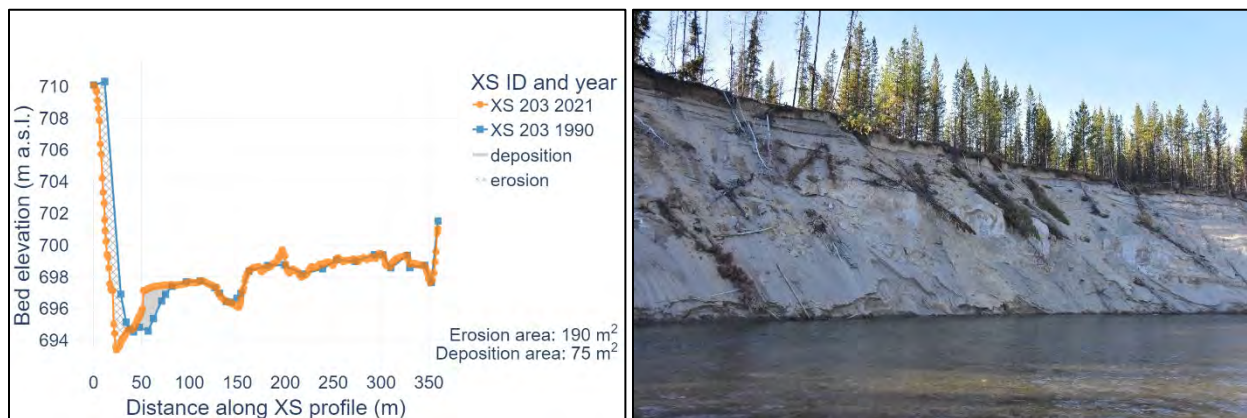
**Figure 4.13 Lateral migration and erosion of the high, glaciolacustrine terrace at XS 203 (1990-2021).**

The downstream-most and final high cutbank within this section of the river is located between XS 204 and XS 202. This high cutbank has also undergone erosion since 1990, as XS 203, located near the middle of the meander, shows that the left (outside) bank of the meander has migrated laterally by approximately 10 m (Figure 4.13).

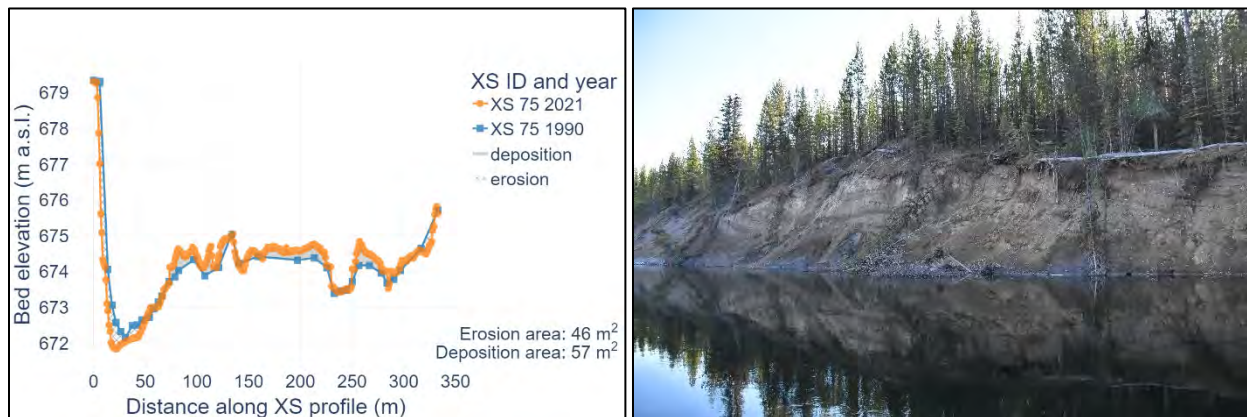
**Figure 4.17 Lateral bank erosion at XS 75 (1990-2021).**

Lateral erosion within this section of the river appears to begin around XS 75 (Figure 4.17). This reach includes numerous properties along the riverbanks, including around Diamond Island from XS 60 to XS 58. Within this area, the historical comparison shows that the dominant channel (or *thalweg*) has shifted laterally as the gravels within the channel are reworked by the flow, with erosion of the floodplain contributing additional gravels to the channel (Figure 4.18). The historical comparison shows that some erosion of the right bank has occurred adjacent to properties located around XS 59 (Figure 4.19).

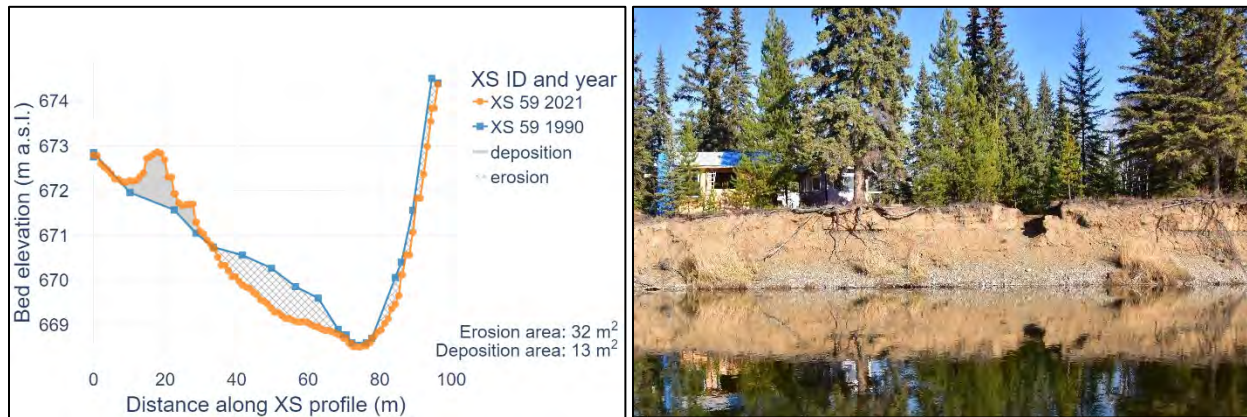
**Figure 4.19 Erosion of the right bank adjacent to properties at XS 59 (1990-2021).**

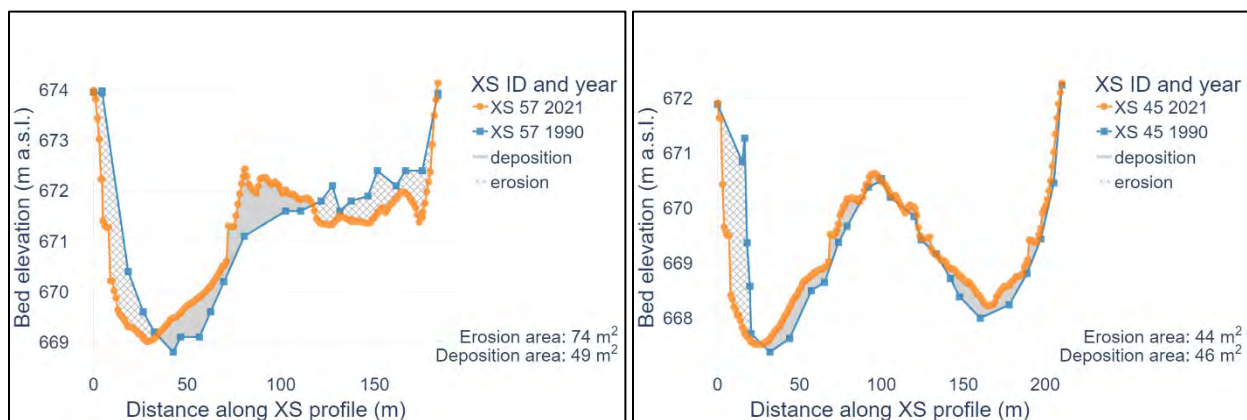
**Figure 4.20 Lateral channel migration and associated erosion of the left bank at XS 57 (left panel) and XS 45 (right panel) (1990-2021).**

Downstream of the residential developments, between XS 59 and XS 42, the banks of the river appear to have remained relatively stable over time, except for lateral channel migration and associated erosion of the left bank at XS 57, XS 48 (minor erosion), and XS 45 (Figure 4.20).

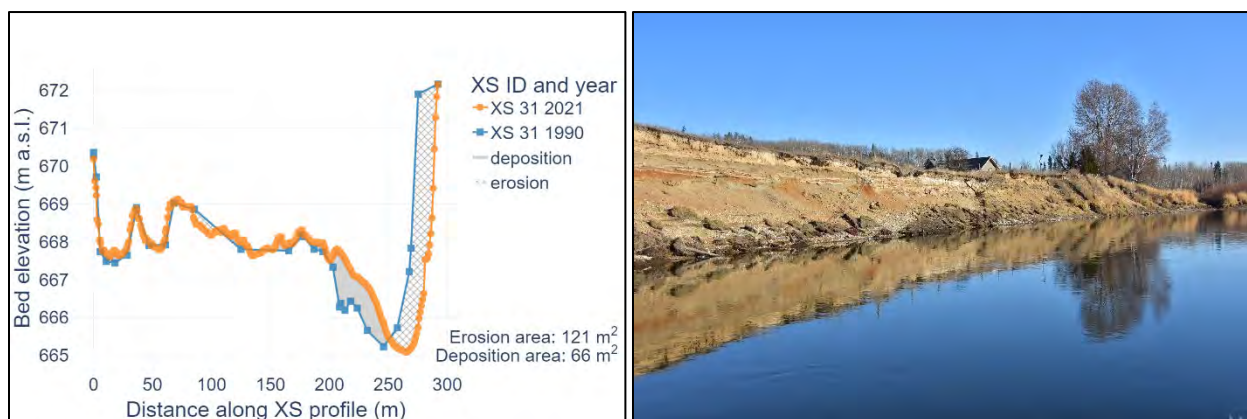
**Figure 4.23 Considerable amount of lateral erosion at XS 31 (1990-2021), located approximately 300 m downstream of a residential building on the right bank.**

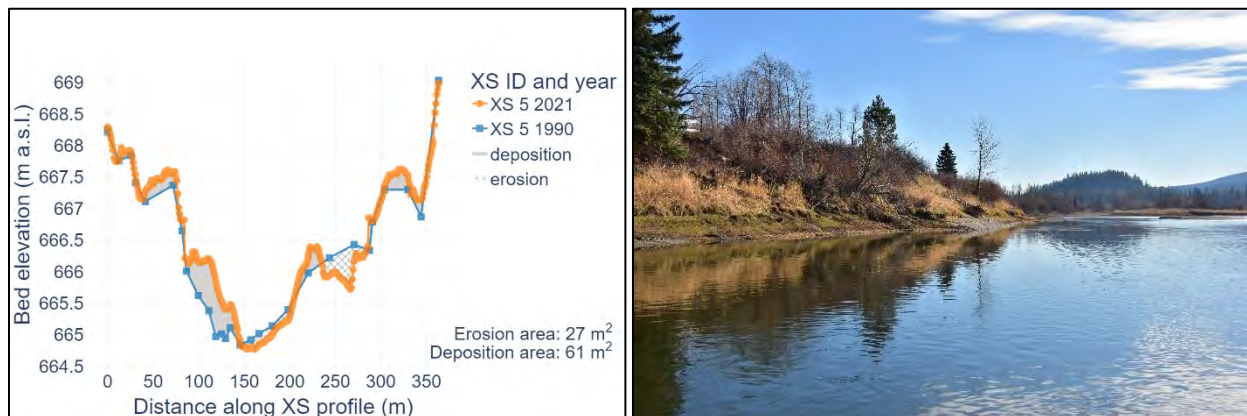
**Figure 4.25 Lateral shifting of the thalweg through the sand-bed reach at XS 5 with generally stable banks (1990-2021).**

In contrast, the bankline adjacent to the residential properties between XS 25 and XS 21 appears to have remained stable since 1990, although the channel appears to be migrating towards the opposite (left) bank in certain locations (Figure 4.24). And finally, at the downstream-most sites near the Nautley River confluence, the historic comparison shows that while the thalweg of the channel has shifted through the sand-bed reach, the positions of the banks have remained generally stable over time (Figure 4.25). Generally, the riverbed in the sand bed reach is expected to be more mobile and thus greater riverbed dynamics are anticipated.

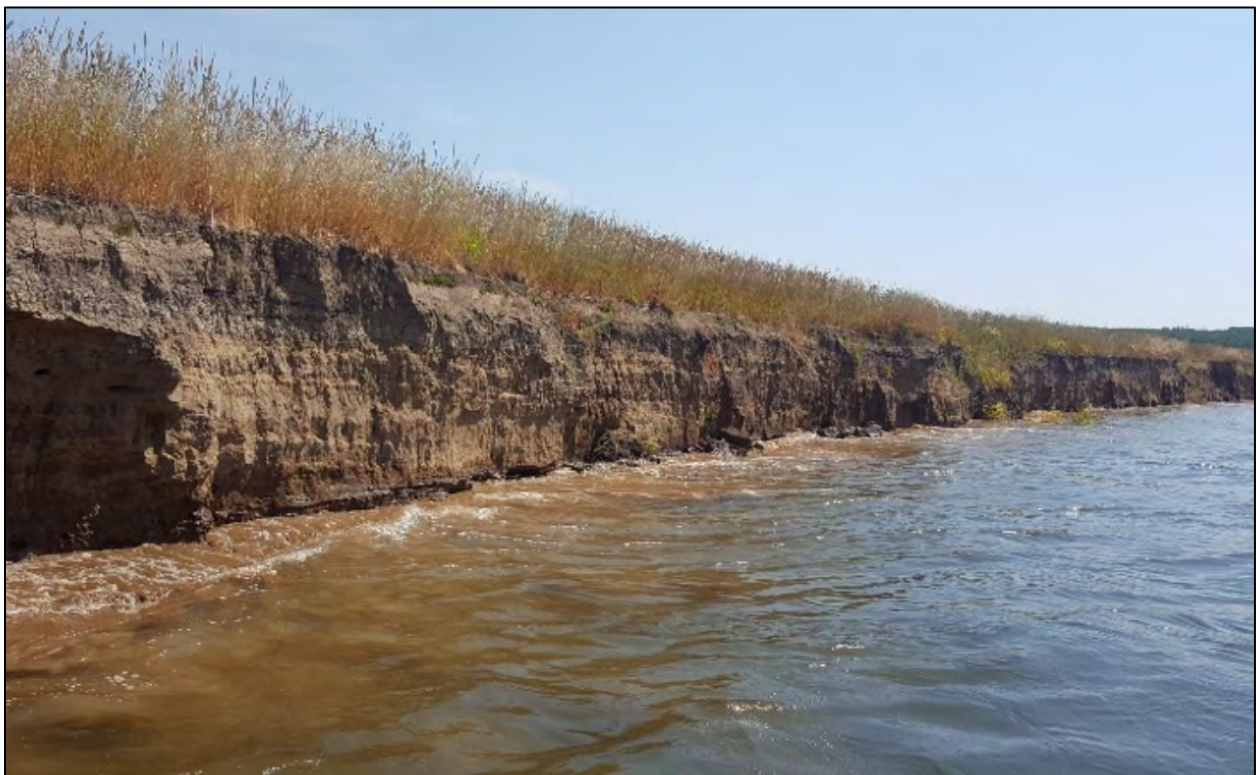
**Photo 4.2** Bank erosion along the agricultural field located approximately 2.5 km downstream of the Burrard Ave. Bridge near RKM 156 (Photo taken on 2017-Aug-07).

The Geomorphic Atlas of the Nechako River (NHC, in prep.) provides a complete description of the reach and a detailed presentation of the change analysis. Herein, a simplified assessment of lateral migration through the Vanderhoof reach was done by comparing orthophotos collected in 2017 and 2021. The two areas which were assessed are known sites of bank erosion: 1) along the right bank at Riverside Park located at River Kilometer (RKM) 152.5 and 2) the agricultural field along the left bank approximately 2.5 km downstream of the Burrard Ave. Bridge near RKM 156 (Photo 4.2).

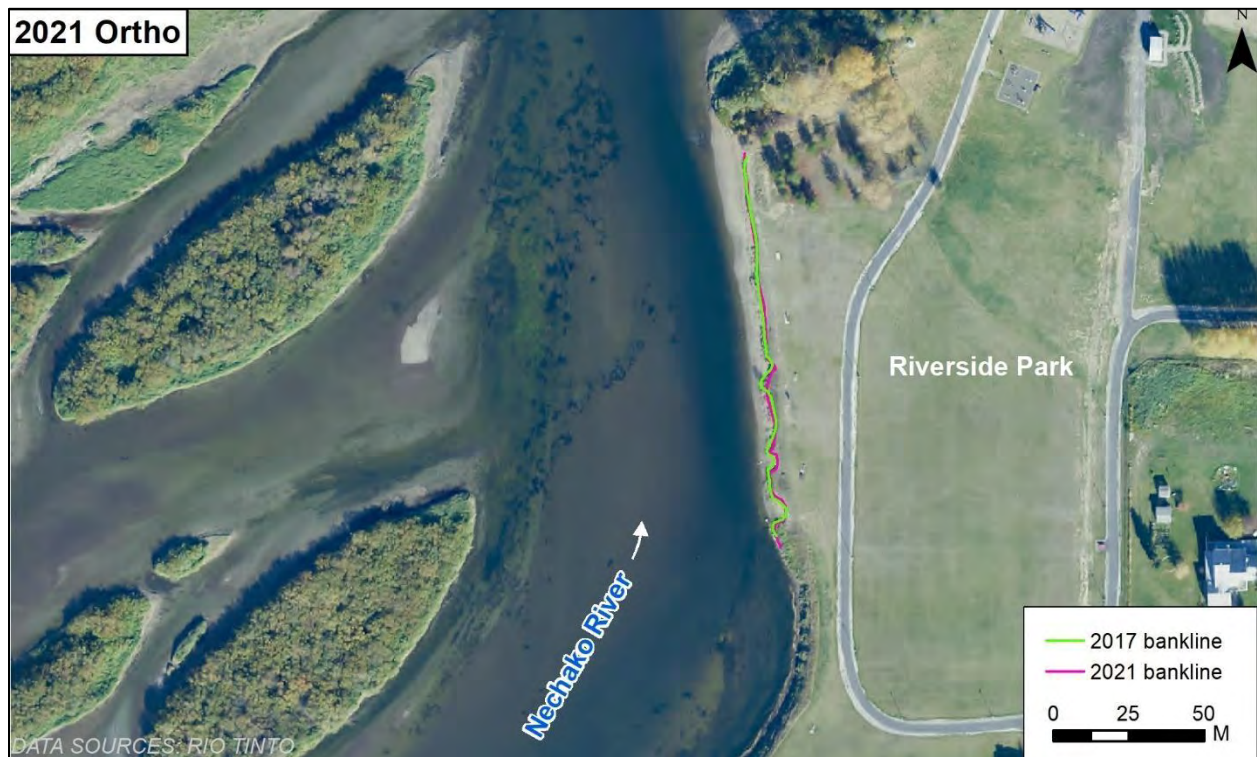
Figure 4.26 Comparison of 2017 and 2021 bankline positions at Riverside Park located at RKM 152.5.

The comparison at both locations shows that some erosion did occur along the bank, but that the extent of erosion was generally limited and highly localized (Figure 4.26; Figure 4.27). The extent of lateral erosion at both locations is estimated to be around 1-2 m of localized erosion over 4 years, although the accuracy of this estimate is limited by the resolution of the aerial imagery. Additional surveys and/or higher resolution aerial imagery could be collected in the future to refine the assessment, as further discussed in Section 6.2.

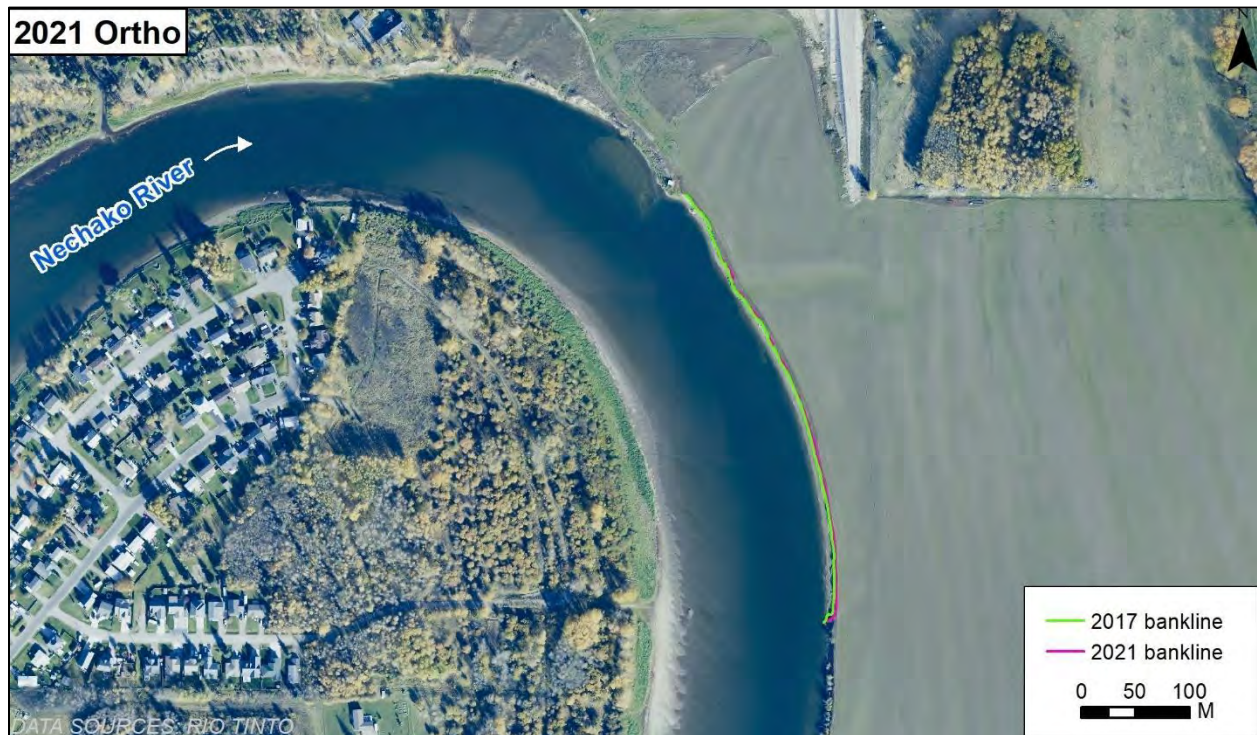
Figure 4.27 Comparison of 2017 and 2021 bankline positions along the agricultural field located near RKM 156.
