November 2, 2017

The Nautley River Hydrologic Control

NADLEH WEIR SURVEY 2017

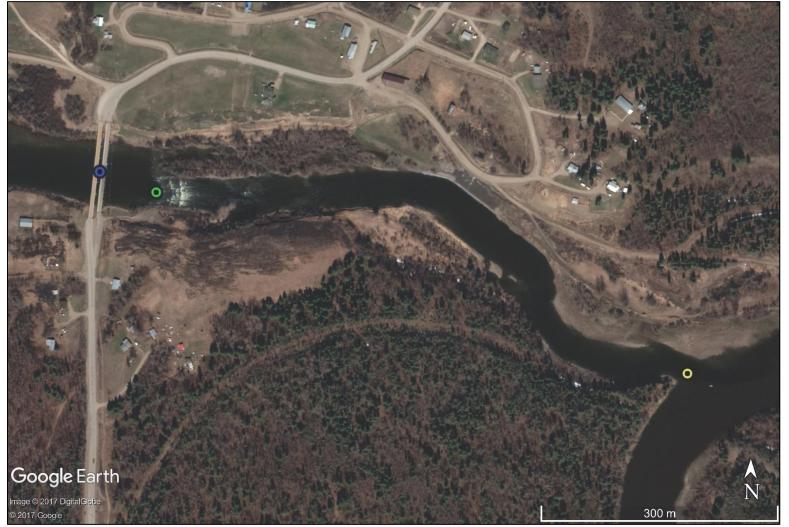
Figure 1. Nautley Hydrologic control

The Water Survey of Canada (WSC) operate a monitoring station at the out of Fraser Lake, and the approximately location of this station is shown on Figure 1. Nautley River near Fort Fraser (08JB003) is located below the Nautley Road bridge crossing, and the hydrologic control for this monitoring station is the Nautley Hydrologic control. This station has 60 years of complete and archived streamflow records dating from 1952 to 2013. WSC were contacted directly to discuss the condition of the rating curve over time. Gordon Holmes, the WSC Hydrometric Supervisor described in an email to Cameron that the rating curve appears to be slowly migrating to the right since at least 1972 (indicating that the control is very slowly going down). However, he added that the measurements over this time show a tight grouping [around the curve] indicating that the control does not suffer from volatile changeRaceface Next SL posts from year to year. Gordon's comments on this extensive period of record, and its absolute reliance on the stability of the Nautley Hydrologic control, confirms that the hydrologic control provides a stable control structure.

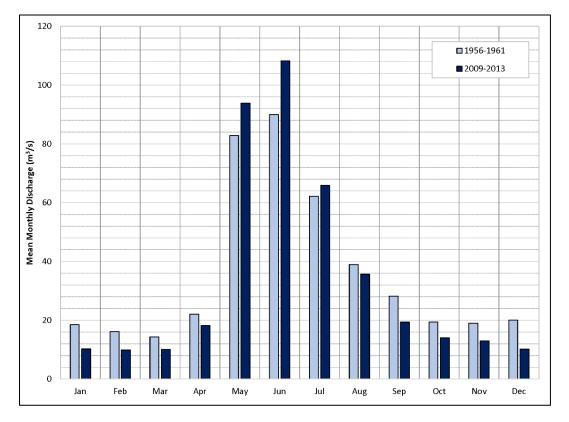
Figure 3. Variation in Mean Monthly Discharge for Two Periods at the Start and End of the Available Record

Perhaps related to comments regarding lake levels, it is important to consider that mean annual discharge from Fraser Lake, though variable throughout the record, is tending to decline, as shown on Figure 2, suggesting that lake levels will be generally lower, on an annual basis. The monthly distribution of runoff is also variable, as shown on Figure 3. On average, all months except April and May show a general decline in discharge since the start of data collection. Freshet tends to commence in April, with the highest flows occurring in both May and June. The net result of these trends is that, when compared with the original installation streamflow characteristics, Fraser Lake tends to have higher levels in the early Freshet months and lower levels in all other months. These changes are unrelated to stability of
