**Ecofish Research Ltd.** Suite 101 - 2918 Eby Street Terrace, B.C. V8G 2X5

## MEMORANDUM

TO: Nechako Water Engagement Initiative Technical Working Group
FROM: Susan Johnson Ph.D., R.P.Bio., Rachel Chudnow, Ph.D., R.P.Bio., Isabelle Girard M.Sc., R.P.Bio., P.Biol., and Jayson Kurtz, B.Sc., R.P.Bio., Ecofish Research Ltd.
DATE: September 19, 2023
FILE: 1316-09

## RE: Fish Access to Nechako River Tributaries and Side Channels – V2

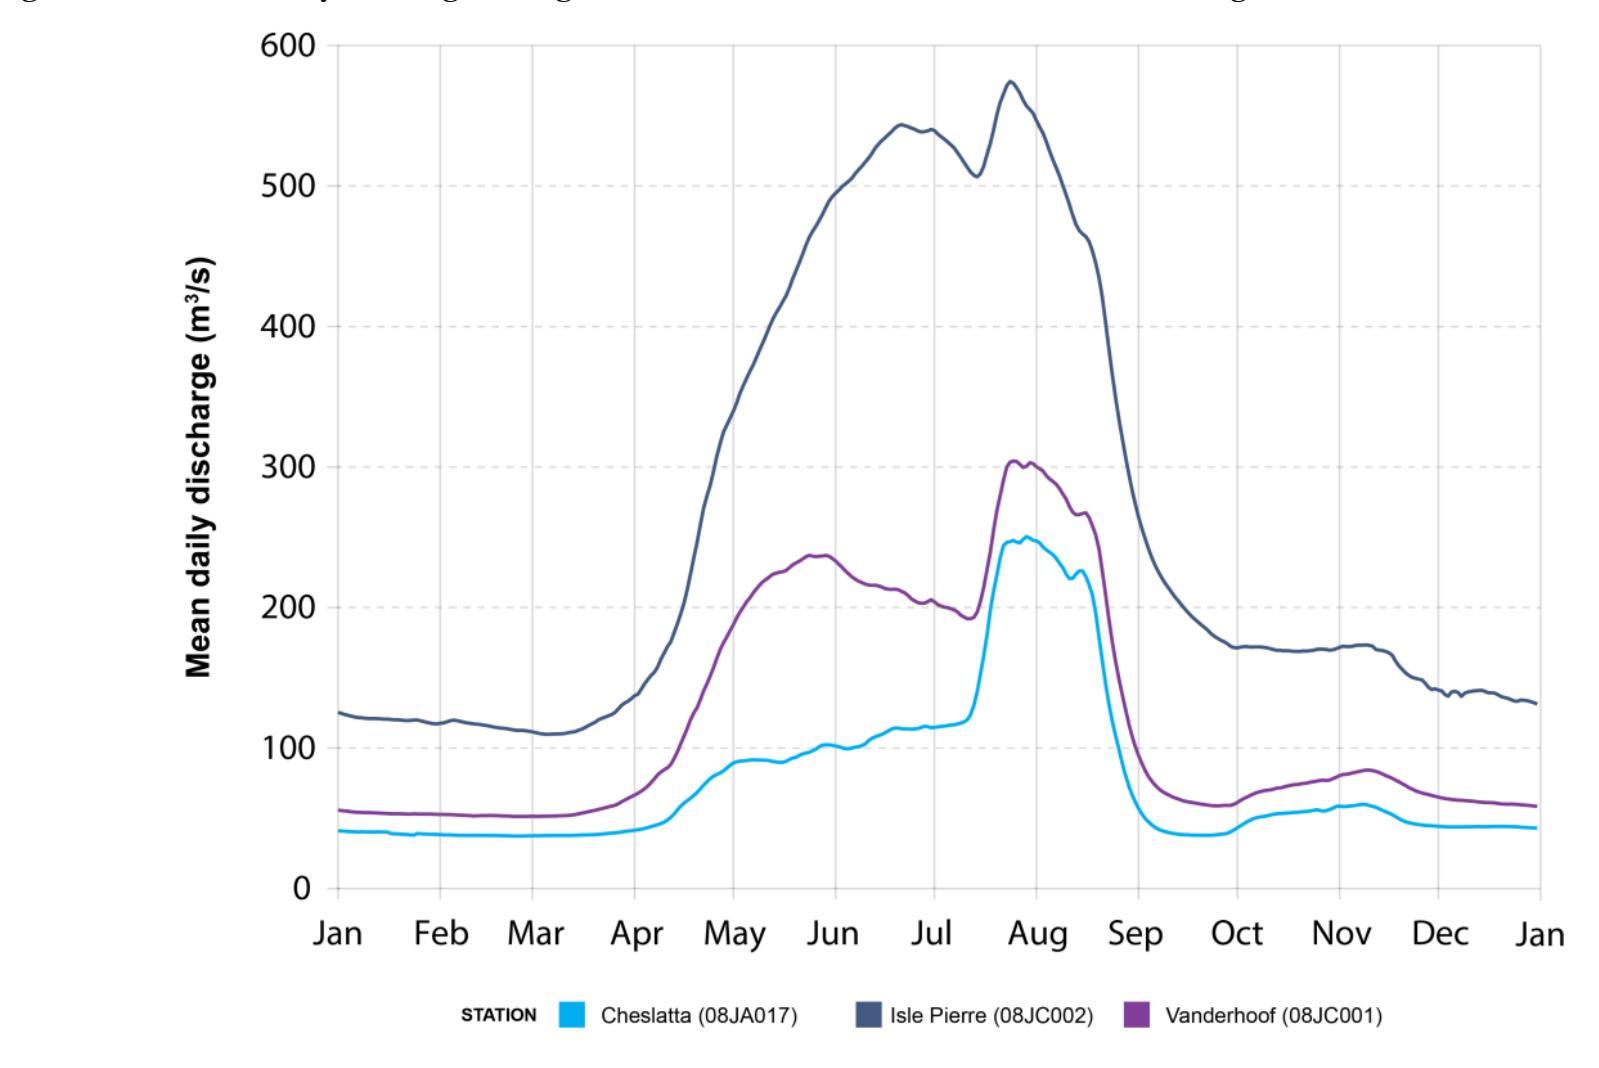
Figure 1. Mean daily discharge during 1990 - 2020 at selected Nechako River monitoring stations.

upper Nechako River (there is minimal local inflow); here, flow is reduced to  $\sim 30\%$  of pre-dam conditions and mean flow ranges from  $\sim 40 \text{ m}^3/\text{s} - 240 \text{ m}^3/\text{s}$  (Figure 1). The Nautley River (~95 km downstream of the dam) combined with local inflows make moderate inflow contributions and mean discharge in the Nechako River at Vanderhoof (~150 km downstream of the dam) ranges from  $\sim 65 \text{ m}^3/\text{s}$  to  $270 \text{ m}^3/\text{s}$ . The Stuart River also contributes significant inflow, and by Isle Pierre (~215 km downstream of the dam) mean flows range from  $\sim 120 \text{ m}^3/\text{s}$  to  $560 \text{ m}^3/\text{s}$ . The Nechako River at Prince George  $\sim 275 \text{ km}$  downstream of the dam. The Nechako River has a hydrograph dominated by snowmelt with a summer freshet.

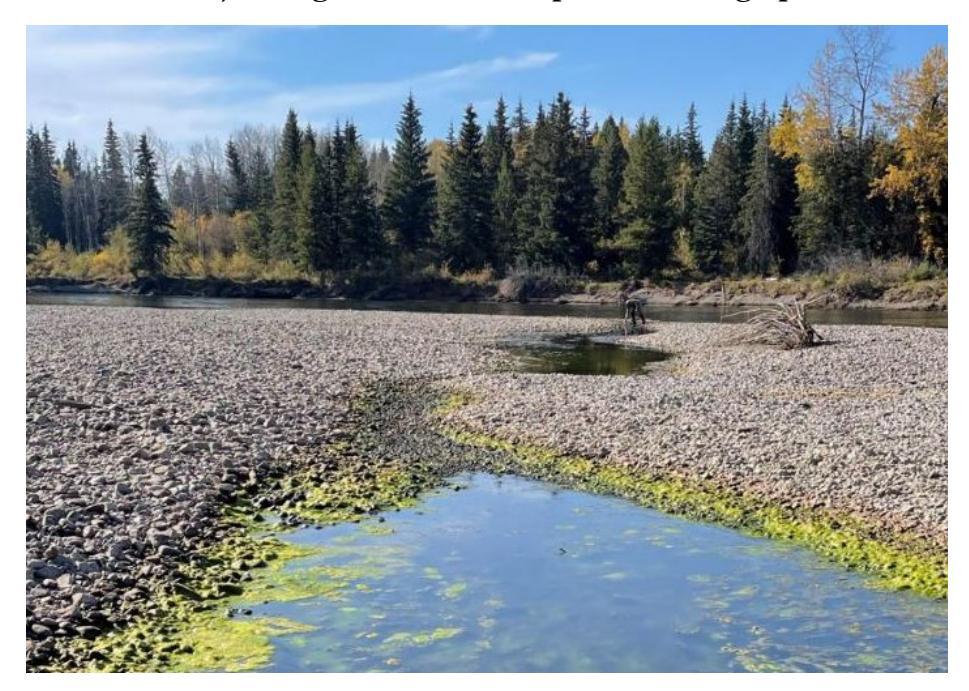
Figure 2. Copely (Targe) Creek confluence with the Nechako River (looking downstream) during the fall low flow period. Photographed on October 6, 2022.

Regehr *et al.* (2023) identified lack of connectivity both at the tributary mouth (Figure 2) and further upstream (Figure 3) at Copely (Targe) Creek. The survey, therefore, concluded low tributary flow was the primary factor limiting habitat connectivity at the tributary mouth; however, some influence of mainstem Nechako River flow may contribute to observed dewatering at the confluence (Regehr *et al.* 2023). No connectivity loss was observed at the mouth of Twin Creek (Regehr *et al.* 2023; Figure 4). However, immediately upstream, barriers to fish access due to low flow and lack of water connectivity within Twin Creek itself were observed (Figure 5). No barriers (i.e., drops, falls), sediment berms, woody debris, or vegetation were observed at either creek.

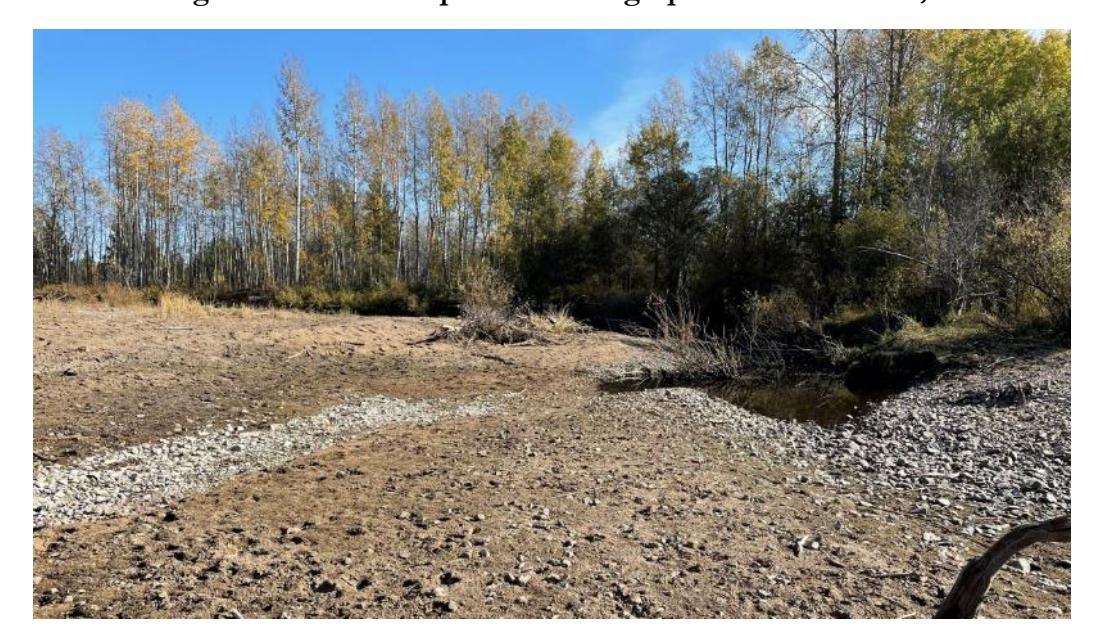
Figure 3. Looking upstream at Copely (Targe) Creek, upstream of the confluence with the Nechako River, showing isolated pools as the result of low tributary flow during the fall low flow period. Photographed on October 6, 2022.

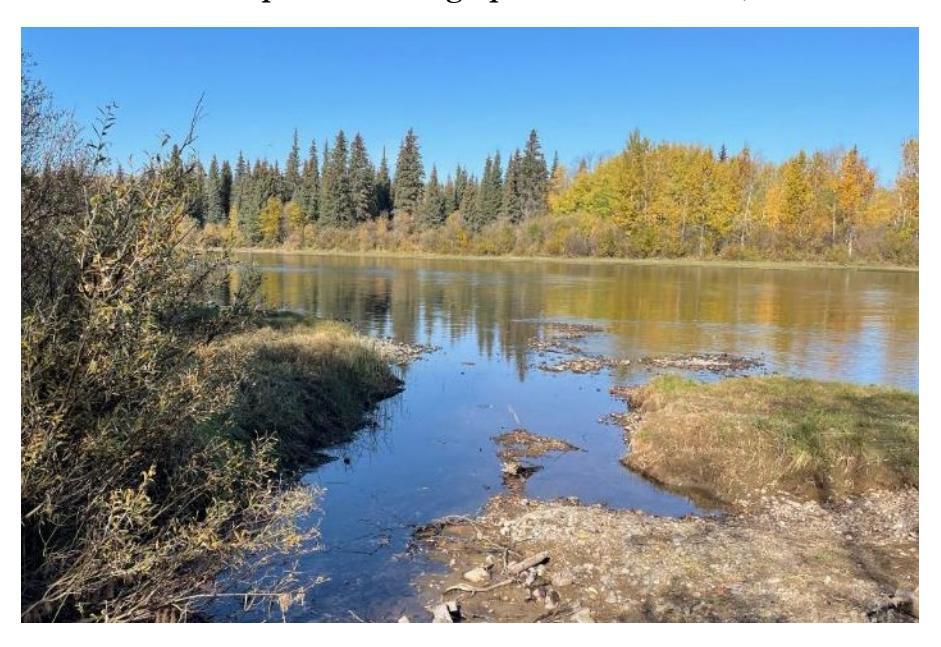
Figure 4. Twin Creek confluence (looking downstream) with the Nechako River during the fall low flow period. Photographed on October 6, 2022.

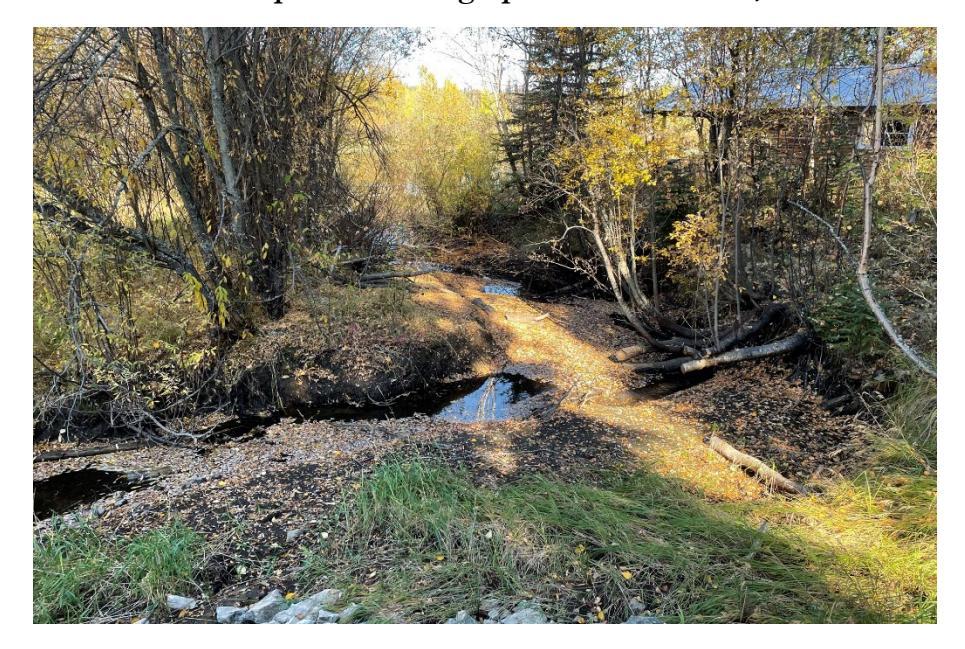
Figure 5. Looking upstream at Twin Creek, upstream of the confluence with the Nechako River, showing isolated pools as the result of low tributary flow during the fall low flow period. Photographed on October 6, 2022.

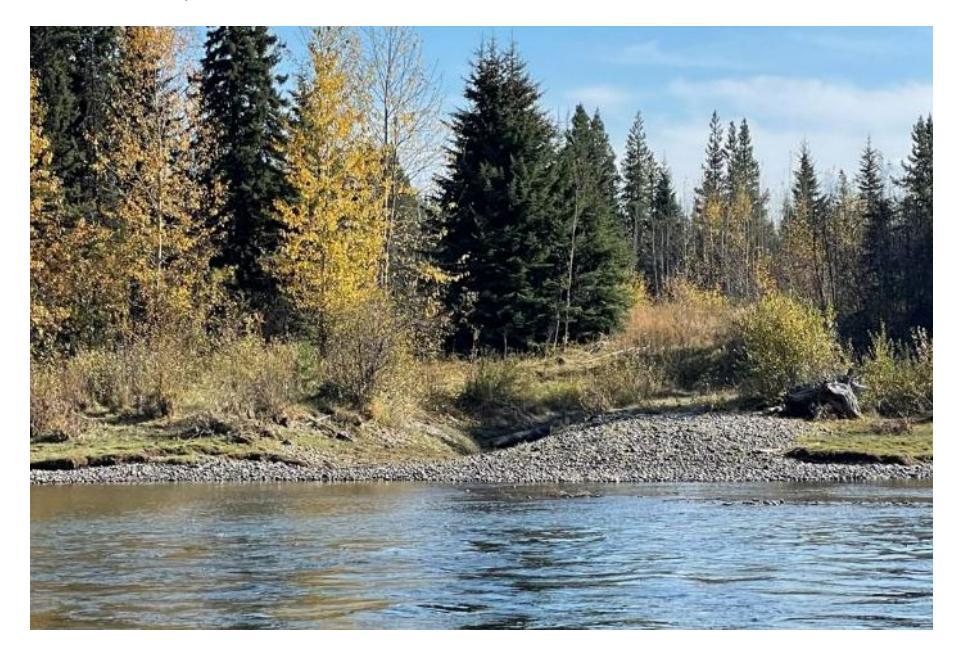
Figure 6. Confluence of Nechako River and Swanson Creek viewed from the river mainstem during the summer low flow period. Photographed on October 6, 2022.

Due to concerns about landowner presence, the 2022 reconnaissance survey was unable to access Swanson Creek on foot (Regehr *et al.* 2023). From what was visible from the river, there appeared to be low to sub-surface flow at the tributary mouth with the presence of a sediment berm (Figure 6). The survey identified low tributary flow as the primary factor limiting habitat connectivity at the mouth of Swanson Creek; however, some influence of mainstem Nechako River flow in combination with accumulated sediment may contribute to dewatering at the confluence (Regehr *et al.* 2023). No other barriers to fish passage (i.e., drops or falls), woody debris, or vegetation affecting fish passage was observed.

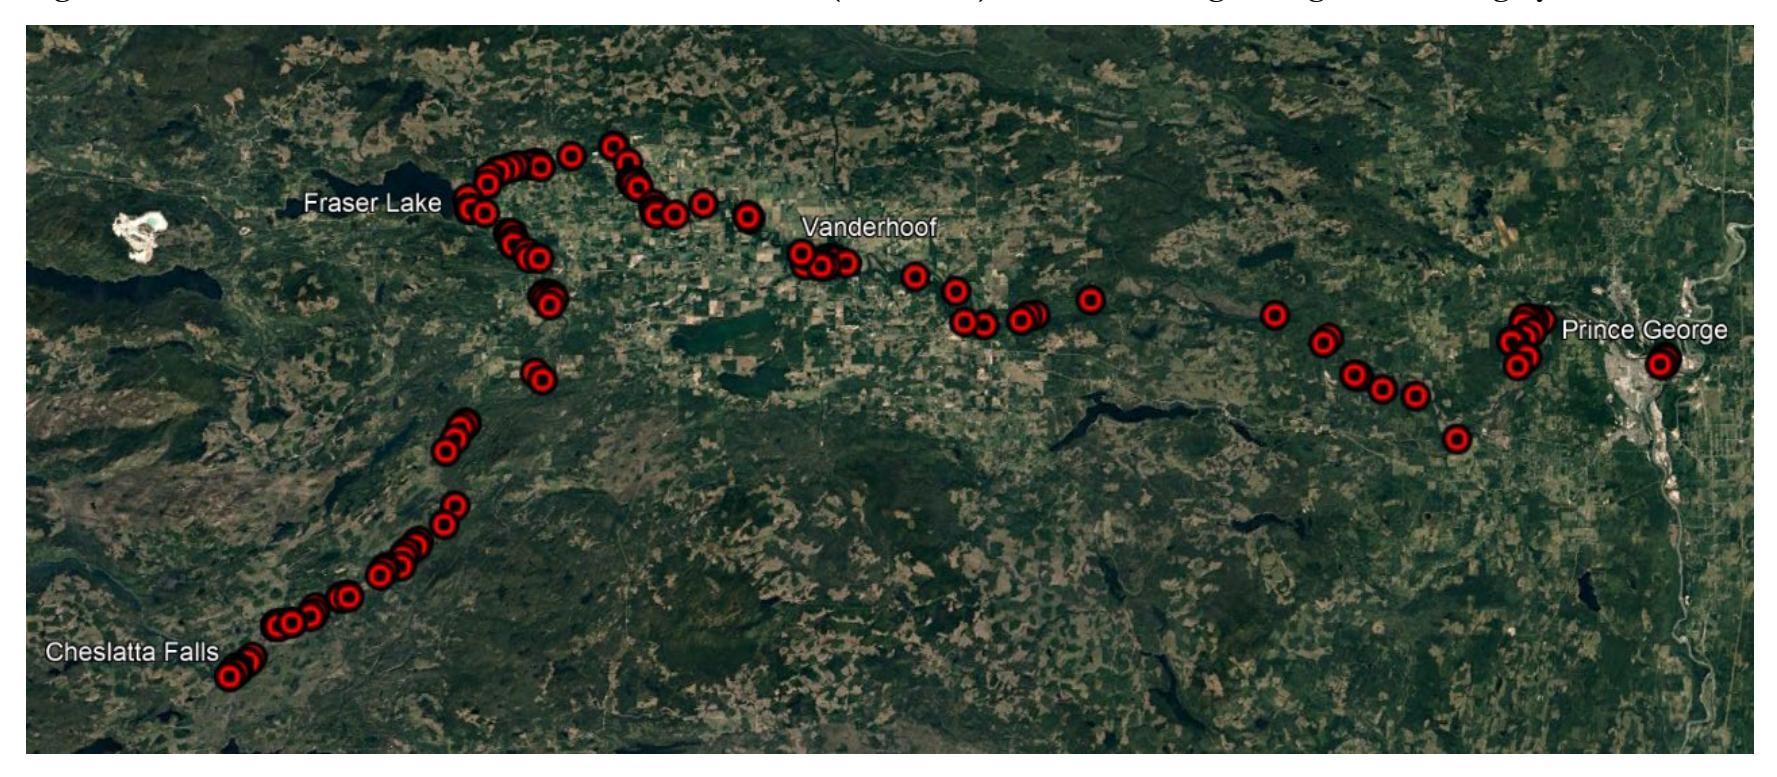
Figure 7. Distribution of Nechako River side channels (red circles) identified through Google Earth imagery.

The Google Earth imagery exercise identified approximately 125 side channels in the Nechako River between Cheslatta Falls and the confluence with the Fraser River that were visible on the imagery in the summer months (Figure 7). Results suggest most side channels are located upstream of Vanderhoof (86 out of 125; 69%). Of the side channels that were observed in the summers (at moderate to high flows) between 2012 to 2021, 41% appeared dry on the imagery (i.e., 35 of 86 side channels upstream of Vanderhoof, 16 of 39 side channels downstream of Vanderhoof). The highest proportion of dry side channels were located upstream of Vanderhoof. Many dry side channels appeared to be partially or completely filled with vegetation, particularly in the river's upstream reaches (Figure 8). However, the mechanism responsible for this vegetative growth is not known. The assessment indicates that most side channels have some fish access at moderate to high flows, but does not identify critical flow levels when fish access will be prevented (i.e., the side channel is dewatered). This assessment also does not identify side channel habitat quality.

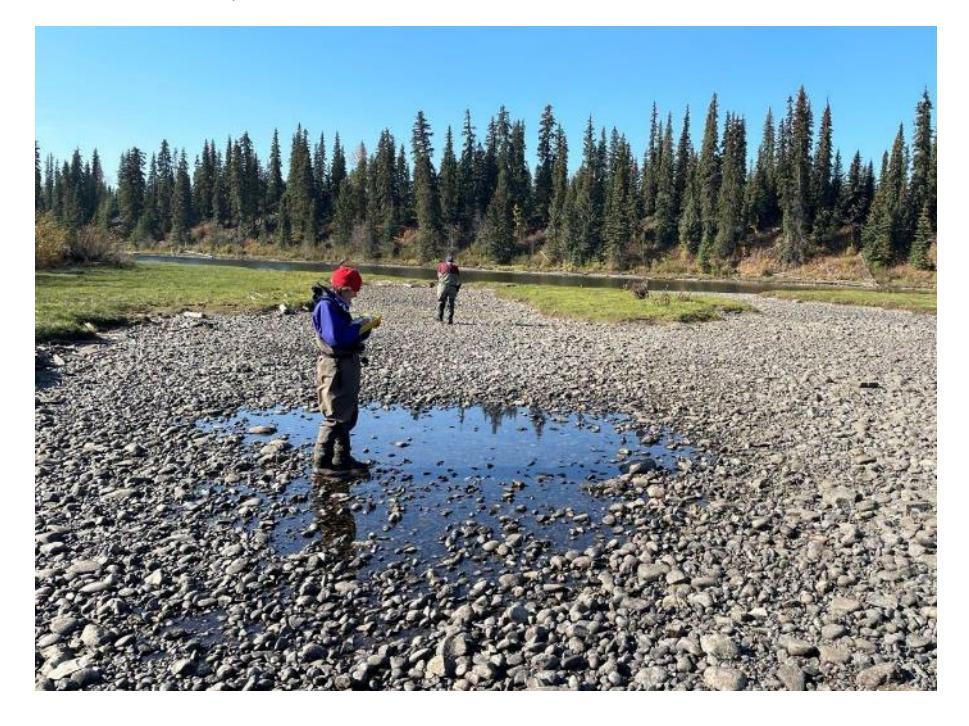
Figure 9. View of dry side channel habitat during the fall low flow period. Photographed on October 6, 2022.

Regehr *et al.* (2023) visited 13 side channels (Table 5). Most (i.e., 12 of 13) provided at least partial access for fish (either the inlet, outlet, or both were wetted). However, the extent or quality of useable habitat was generally not assessed, and dewatered inlet channels restricted fish access and useable habitat. Further, this survey may have been biased toward wetted channels as they were more easily differentiated from the river mainstem when viewed from the vessel. No obvious barriers to fish access (i.e., drops, woody debris, sediment berms, vegetation) were observed at any side channels visited. It therefore appears that flows at the time of survey were not sufficient to maintain connectivity in the side channels found to contain dewatered areas (i.e., inlet dewatering as the result of the side channel inlet being located at higher elevation than mainstem water elevation). For one side channel visited in the upper river (i.e., side channel #11 in Regehr *et al.* 2023), dewatering<sup>5</sup> appeared recent and resulted in substantial portion of the side channel being dry and inaccessible to fish (Figure 9).

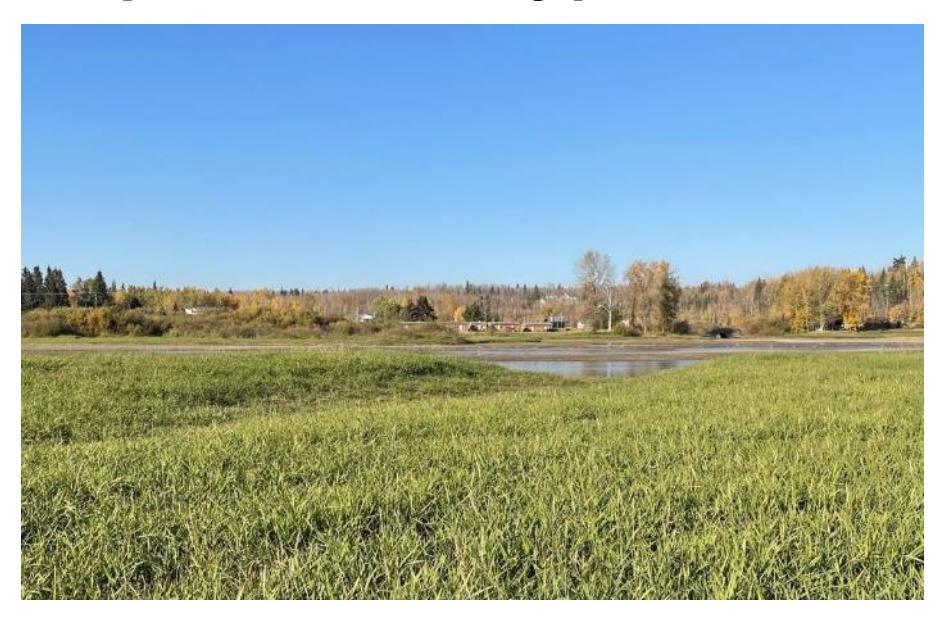
Figure 10. View of side channel outlet showing extensive reed canary grass in the braided area upstream of Vanderhoof. Photographed on October 6, 2022.

sanctuary area, understood to previously be cobble and gravel, were found to contain finer substrate (sand, silt) and were heavily colonized by Reed Canarygrass (*Alaris arundinacea;* Figure 10; Figure 11). The extent to which vegetation in this area could limit or prevent fish passage was not clear at the time of survey.

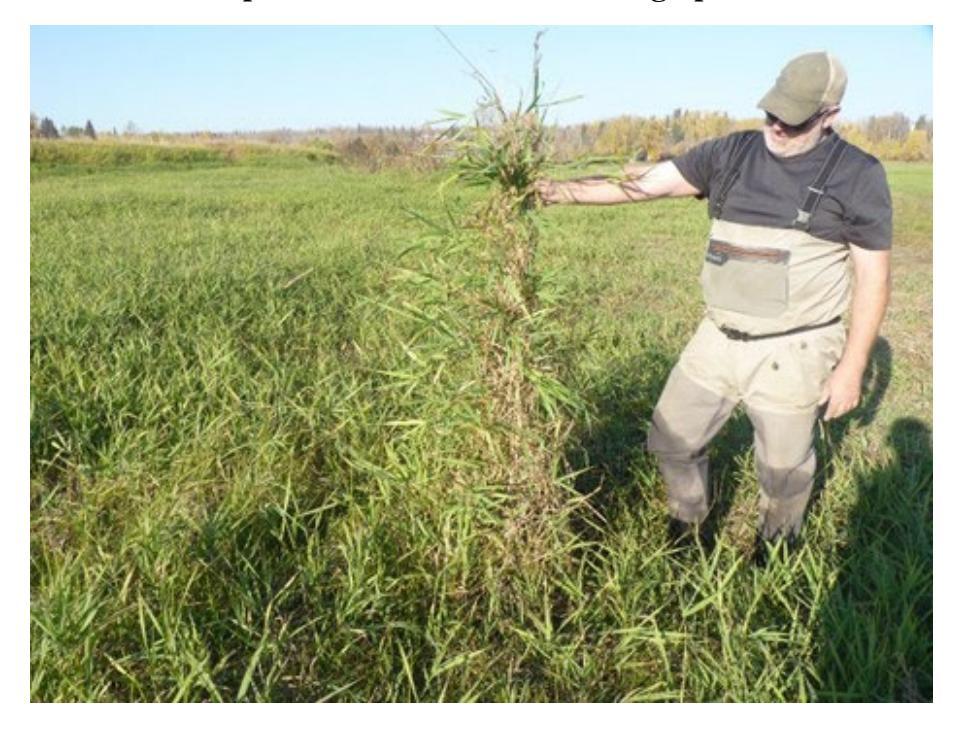
Figure 11. Extensive area with reed canary grass adjacent to the Nechako River in the braided area upstream of Vanderhoof. Photographed on October 6, 2022.
